Appendix B

CRASH SITE AND DAMAGES

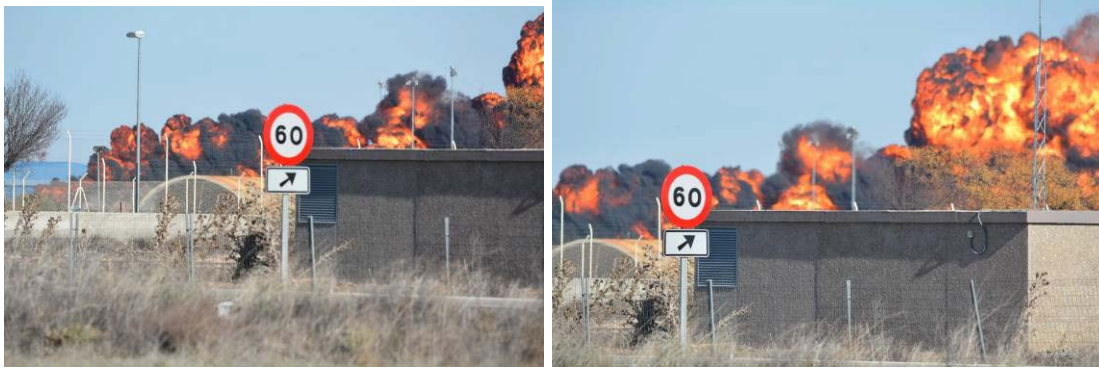
Pictures B-3: View of massive fireball created by the accident (size of the fireball can be compared to the size of the shelter in front of it)

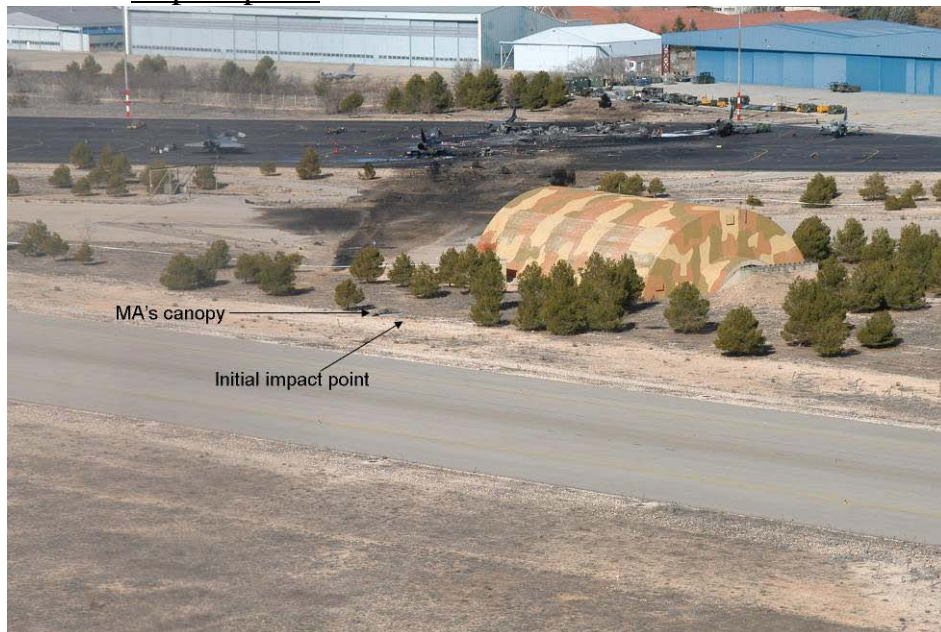
Picture B-4: Aerial view of the crash site as viewed from the runway

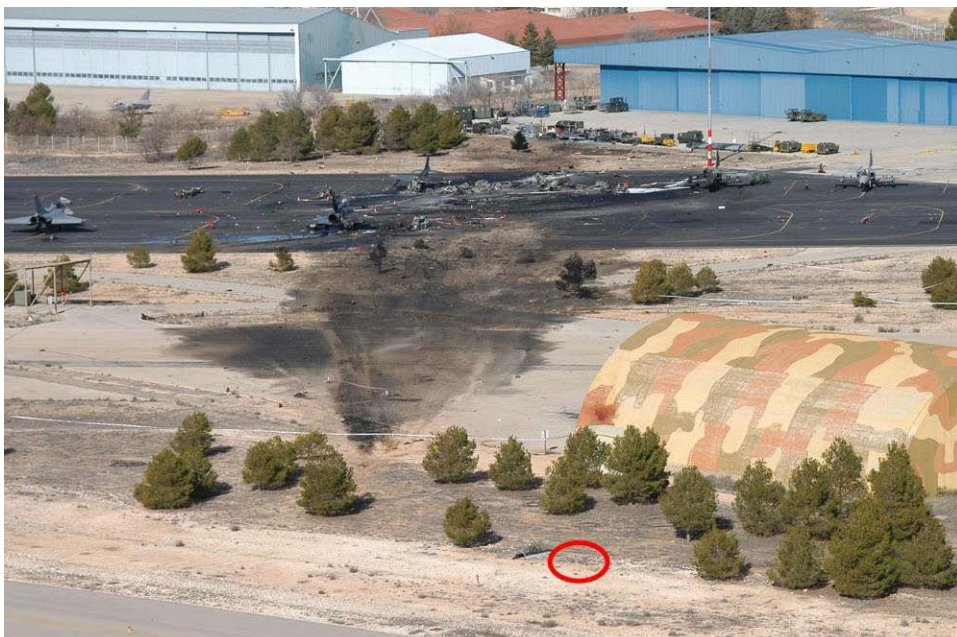
1. Impact point

Picture B-5: Close view of the impact point

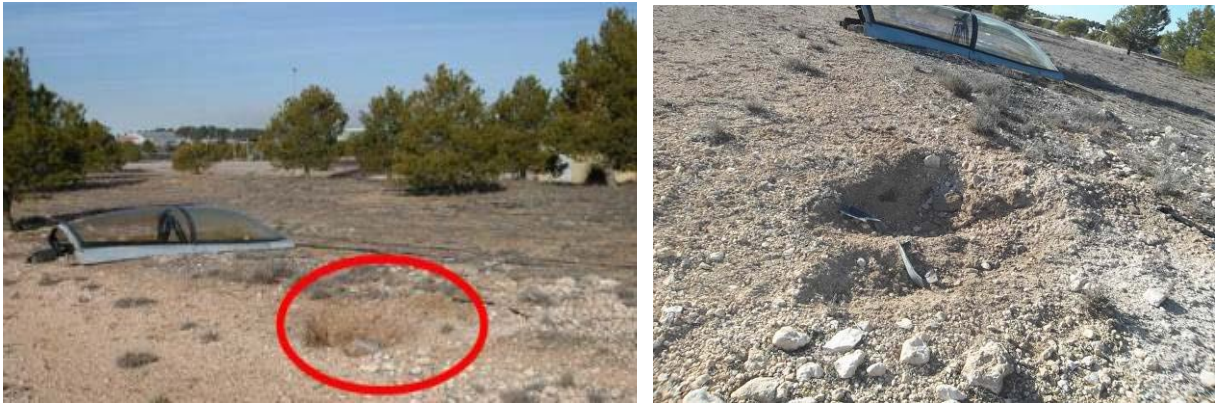
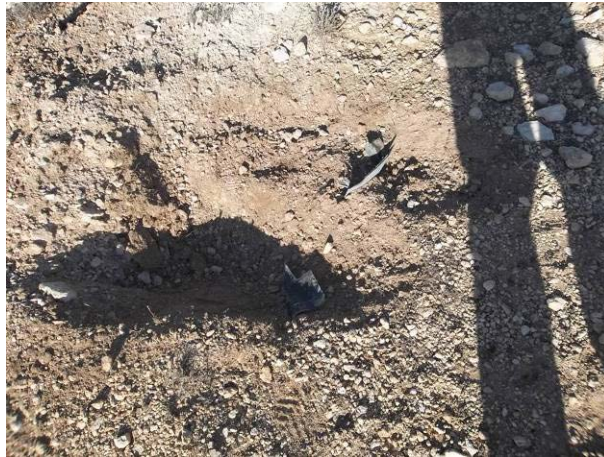
Pictures B-6: Views of the initial impact point

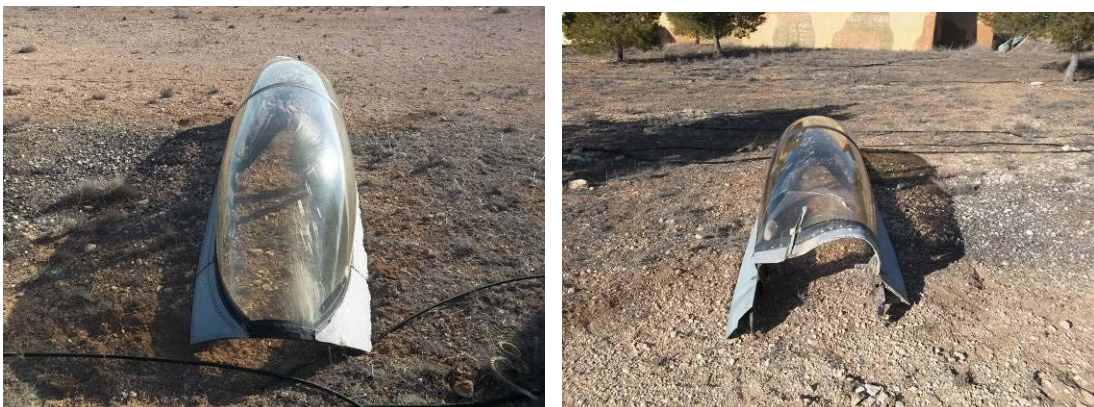
2. Canopy

The first part of the A/C found was the canopy (approximately 20m close to the shelter D-4). It was found in good condition whereas canopy remover rocket motors and their detonation transfer assemblies were activated.

Pictures B- 7: Front and rear view of the canopy

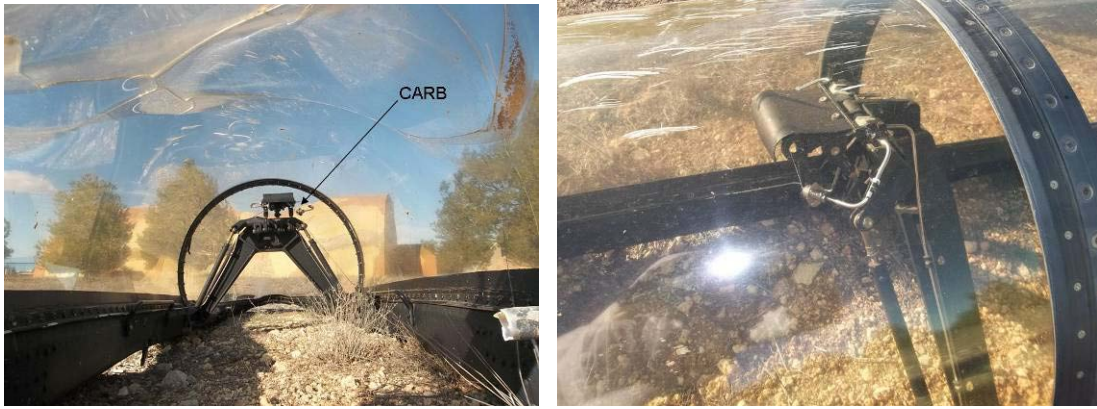
Pictures B-8: Canopy Release Bolt (CARB) properly operated

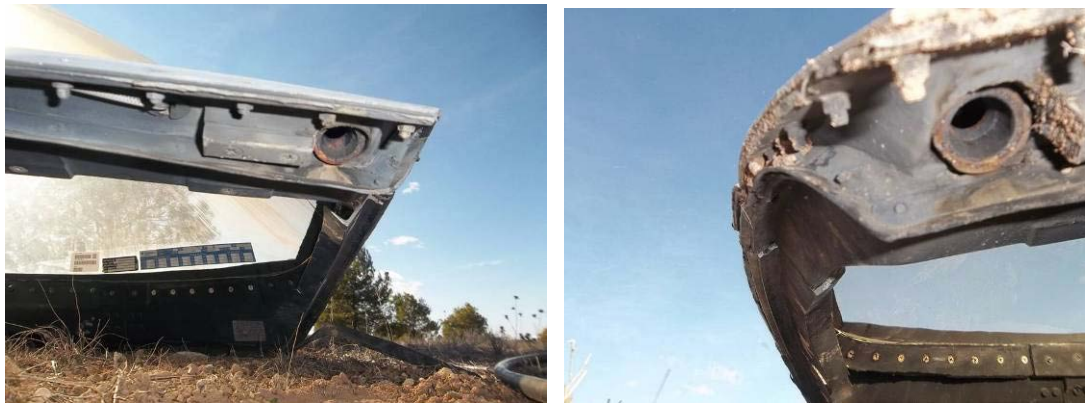
Pictures B-9: Canopy Remover Assemblies properly operated

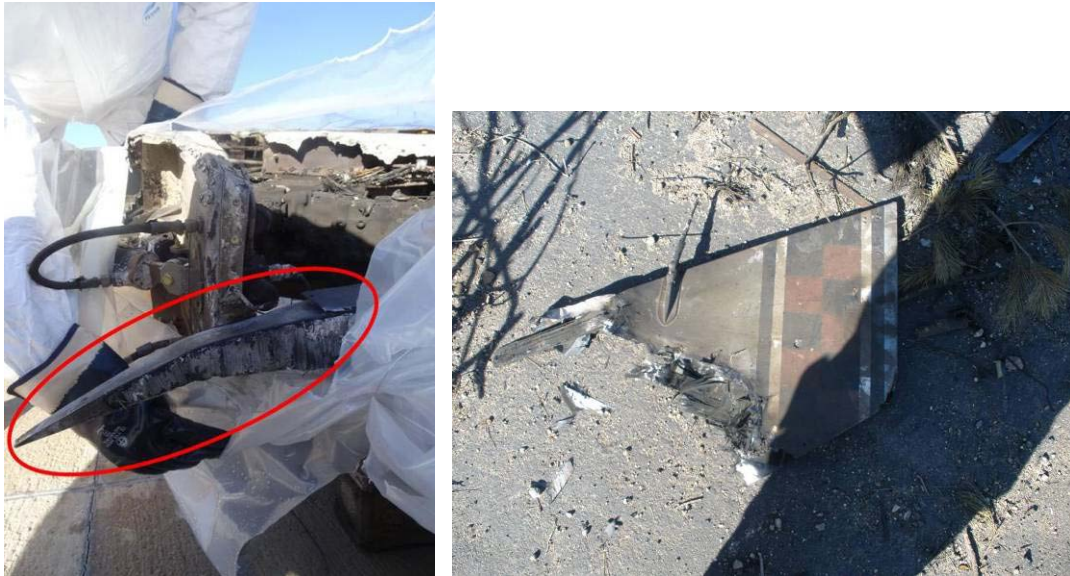
5. Rudder

Part of the rudder was found burnt and destroyed just before E2 Parking Rump. However several pieces of it were found at different locations.

Pictures B-10: Parts of the rudder

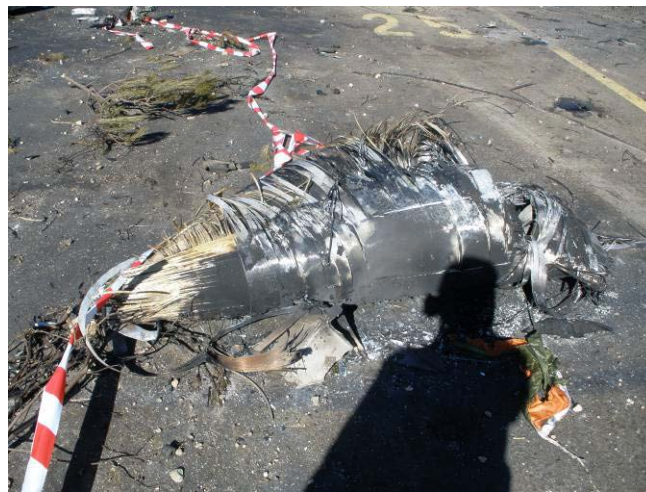
6. Radome

MA's radome was found totally burnt and destroyed at E-2 Parking Rump, next to FRA Mirage 2000-5 S/N 669.

Picture B-11: The radome totally destroyed

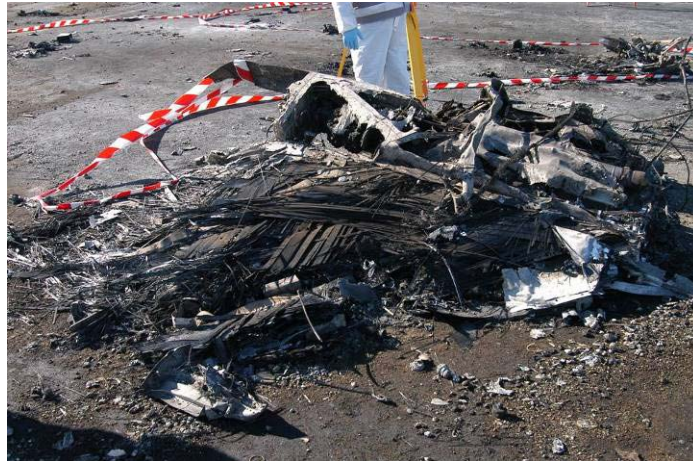
7. Vertical Stabilizer

Vertical Stabilizer was found fully burnt and destroyed close to ITA AMX S/N 7193.

Picture B-12: Parts of vertical stabilizer

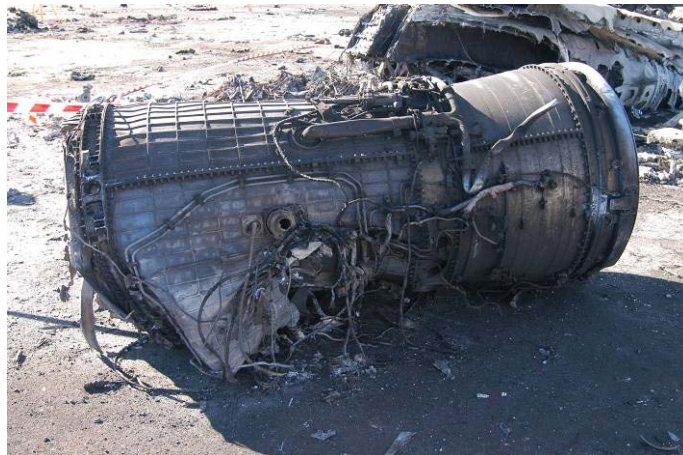
8. Engine

MA's engine was found with serious damages without exhaust nozzles and augments close to ITA AMX S/N 7193. In that location, there were debris of the totally destroyed FRA Alpha-Jet S/N E047 and Mirage 2000-5 S/N 651 too.

Picture B-13: Engine general view

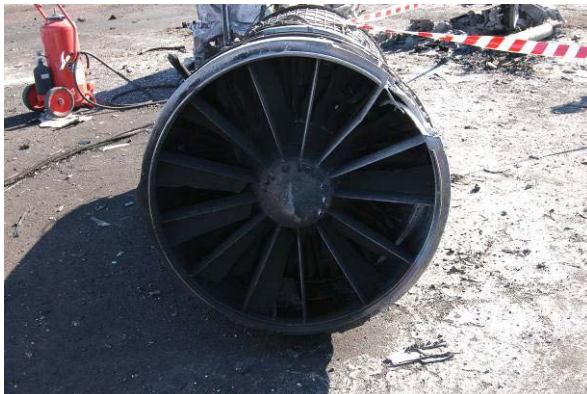
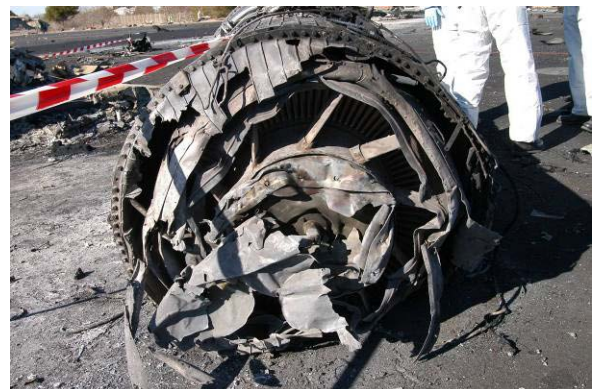
Pictures B-14: Engine forward and rear view

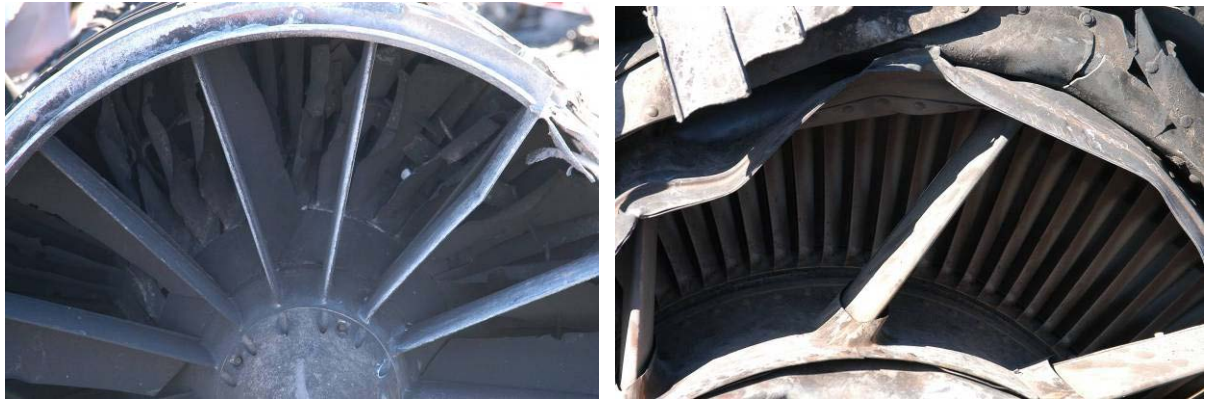
Pictures B-15: Engine forward and rear close view

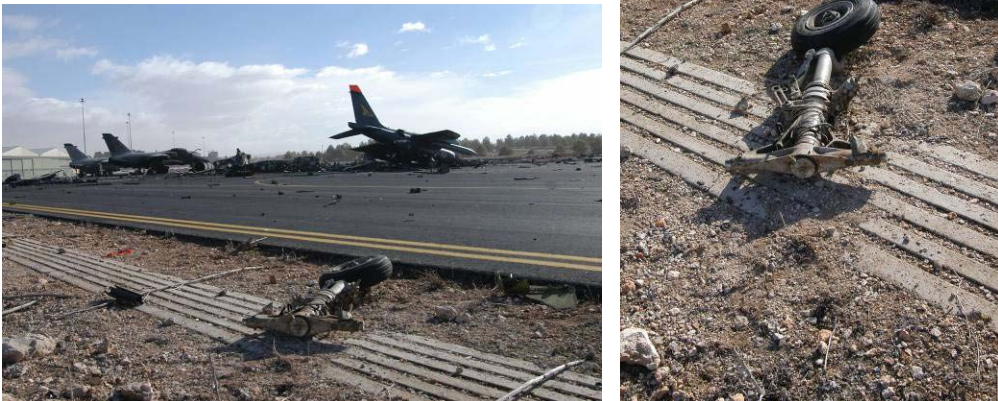
9. Nose Landing Gear (NLG)

It was found 30 m from the engine but in the same level, perpendicular to the longitudinal axis of A/C crash pattern.

Pictures B-16: NLG assembly

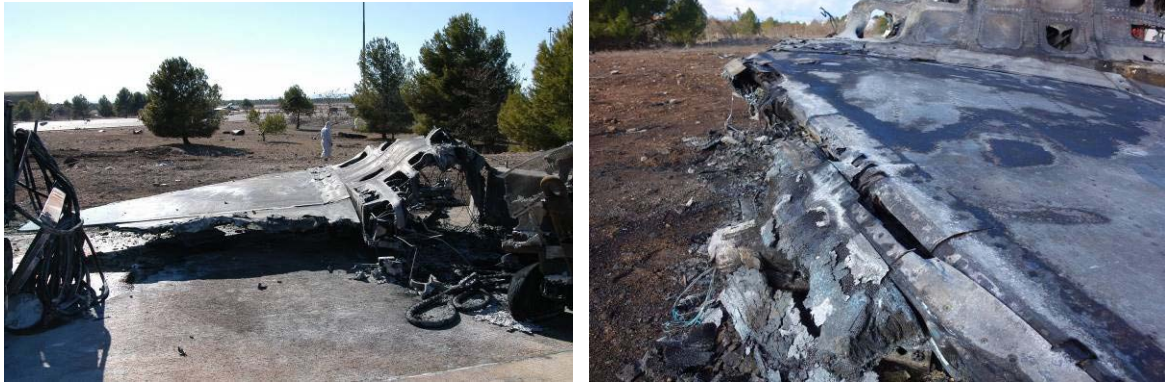
10. LH Wing

LH Wing was found seriously damaged and burnt, in the area in front of TLP hangar.

Pictures B-17: The LH wing (rear view) and close view of LH Leading Edge Flap

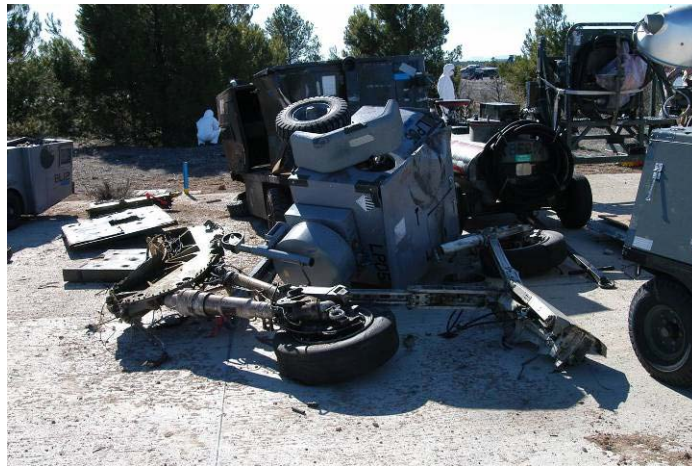
11. Main Landing Gear (MLG)

MLG system was found close to LH Wing.

Picture B-18: MLG and drifted ground equipment

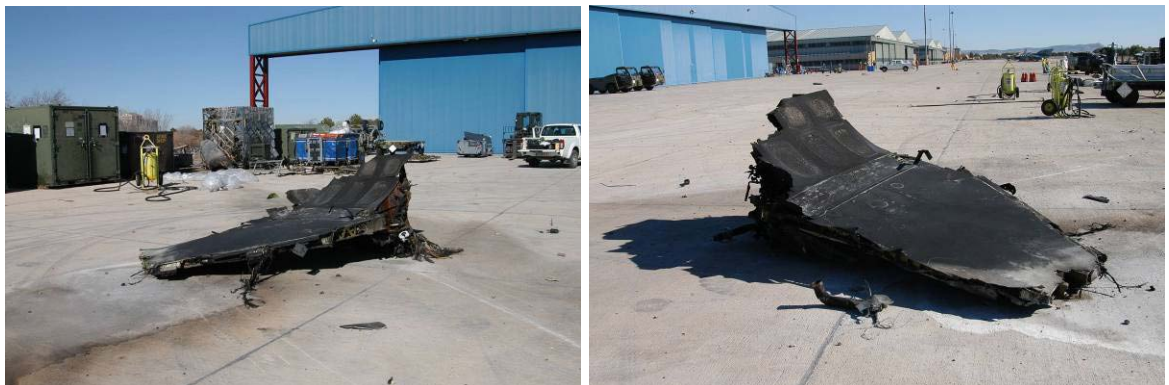
12. RH Wing

RH Wing joint with part of upper surface were found burnt and damaged in front of the TLP hangar.

Pictures B-19: RH wing totally burnt

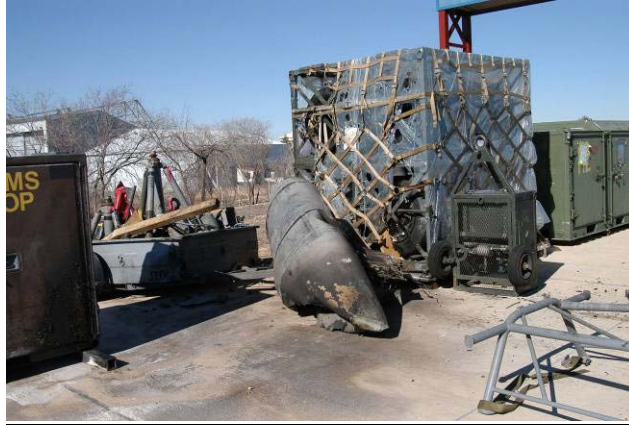
13. C/L Tank

C/L Tank joint with C/L pylon were found totally destroyed and burnt at the very end of maintenance area close to the corner of TLP hangar.

Picture B-20: C/L tank and ground equipment

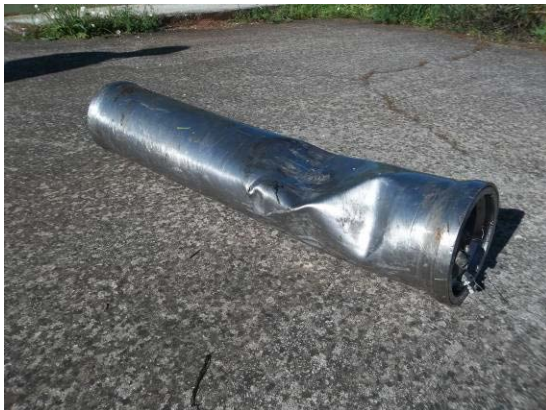
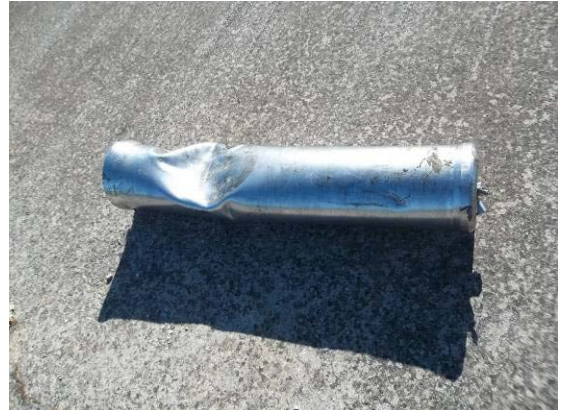
14. Hydrazine Tank

Pictures B-21: View of hydrazine tank's distortion (All Hydrazine tank pictures have been taken in Greece and not at crash site)

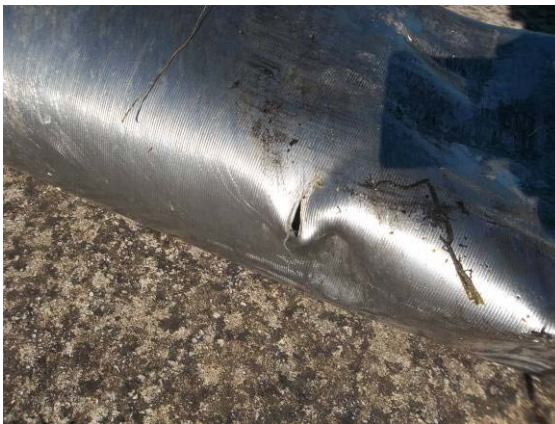
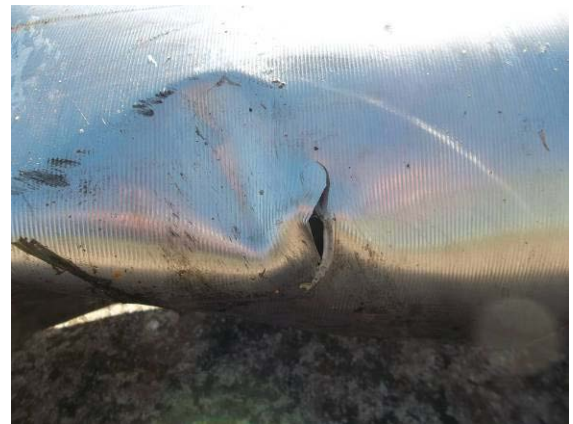
Pictures B-22: Close view of the fracture of the case of hydrazine tank. Hydrazine had been leaked from that point.

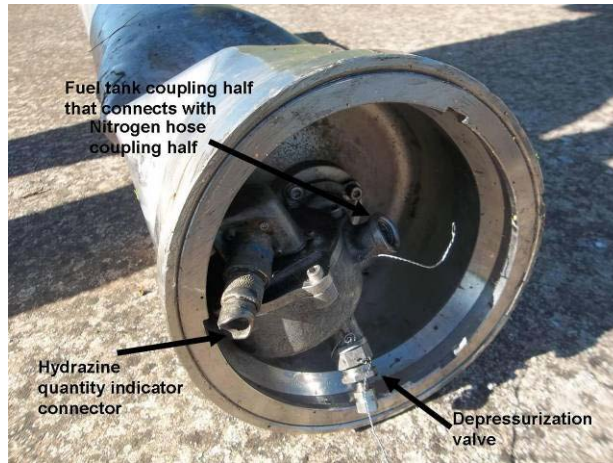
Picture B-23: Damages on FWD section of hydrazine tank.

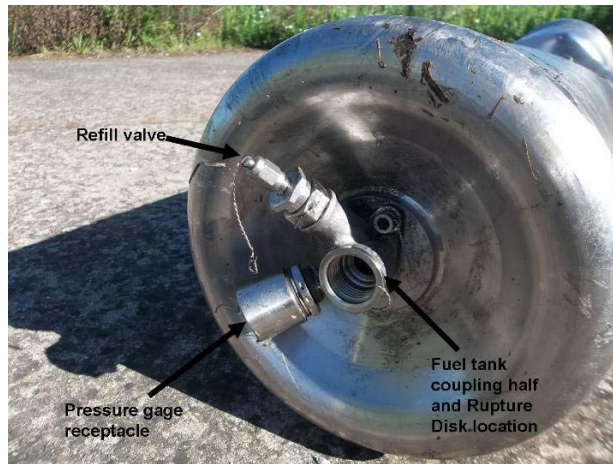
Picture B-24: Damages at AFT section of hydrazine tank. Rupture disk was found broken, however it was activated due to ground impact and not as a result of Emergency Power Unit (EPU) activation

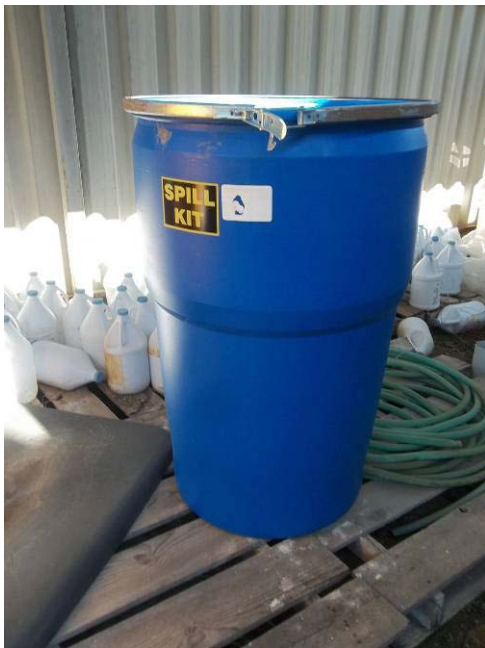
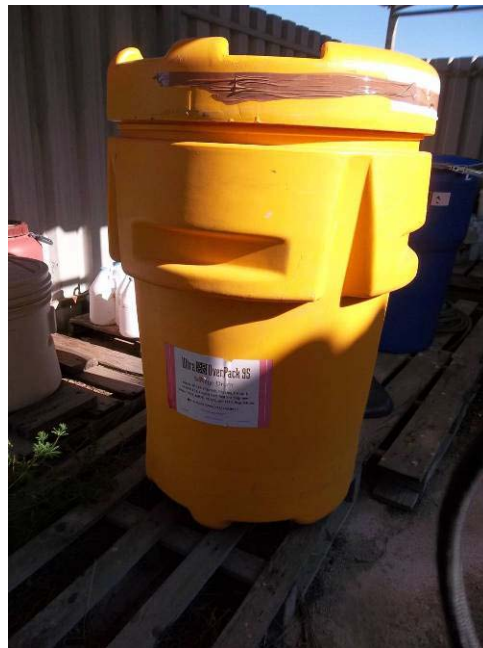
Pictures B-25: Hydrazine contaminated soil collected in special spill kit and hydrazine tank was stored in adequate salvage drum. Due to hydrazine tank's deformation it could not be installed in its appropriate container.

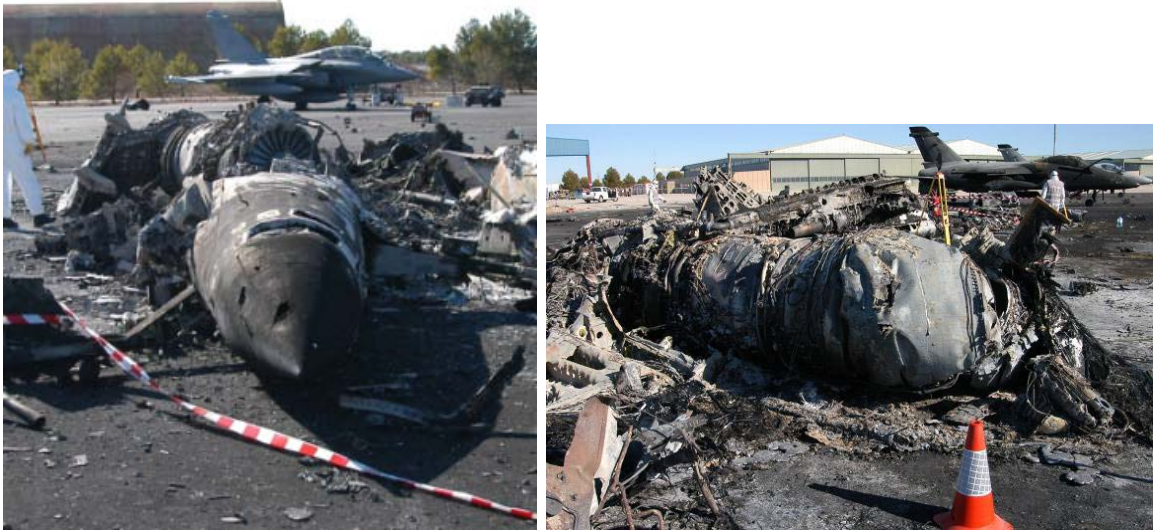
15. Mirage 2000D S/N 651

Mirage 2000D S/N 651 absorbed MA's momentum after the crash. It was drifted towards the Alpha-Jets and totally destroyed.

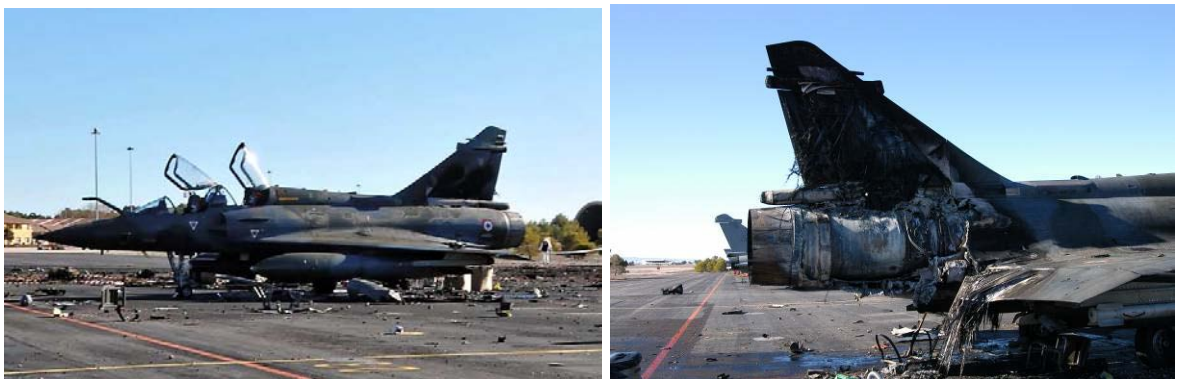
16. Mirage 2000D S/N 669

Mirage 2000D S/N 669 was located next to Mirage 2000D S/N 651 which substantially absorbed MA's momentum after the crash. In consequence, Mirage 2000D S/N 669 was seriously damaged.

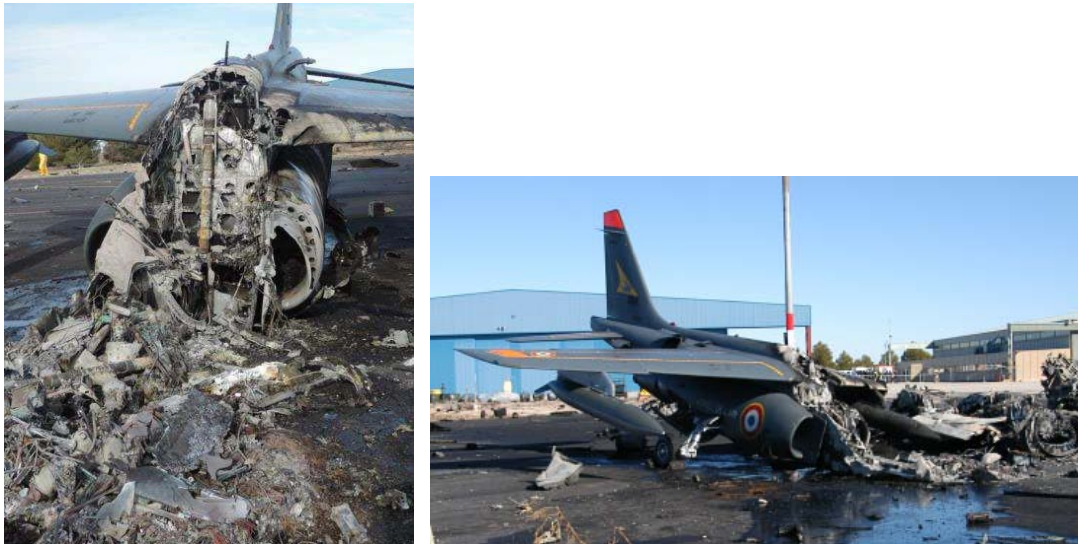
17. Alpha-Jet S/N E096

Mirage 2000D S/N 651, drifted by MA and impacted on Alpha-Jets. Alpha-Jet S/N E096 substantially damaged.

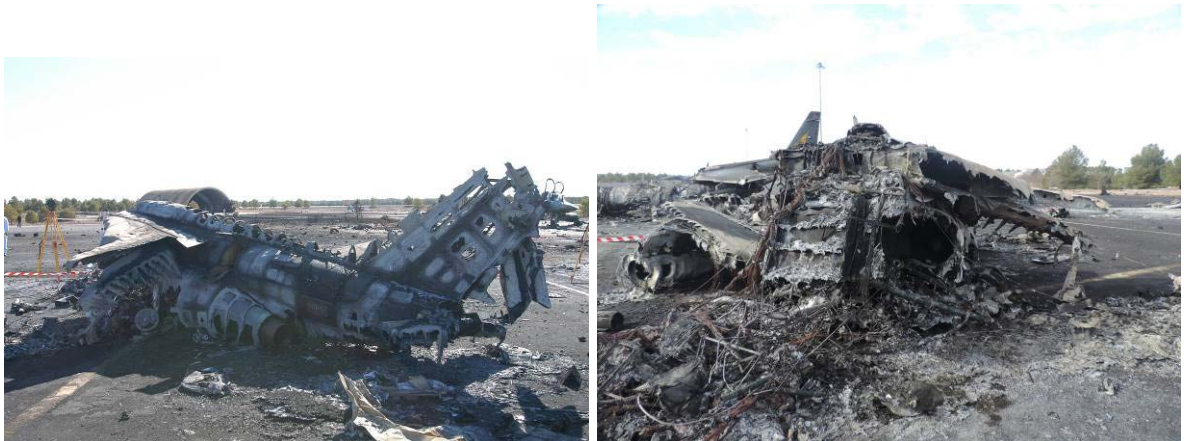
18. Alpha-Jet S/N E047

Alpha-Jet S/N E047 was totally destroyed.

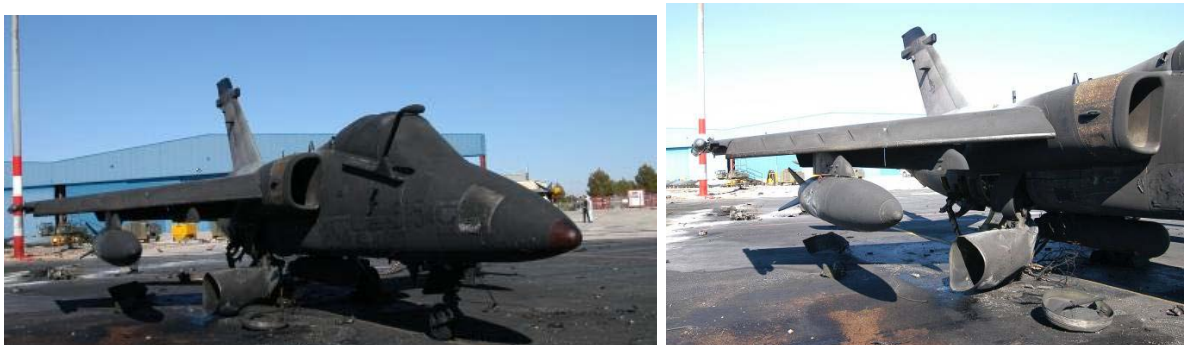
19. AMX S/N 7193

It was located next to Alpha-Jet S/N E047 and got totally unserviceable by the fire.

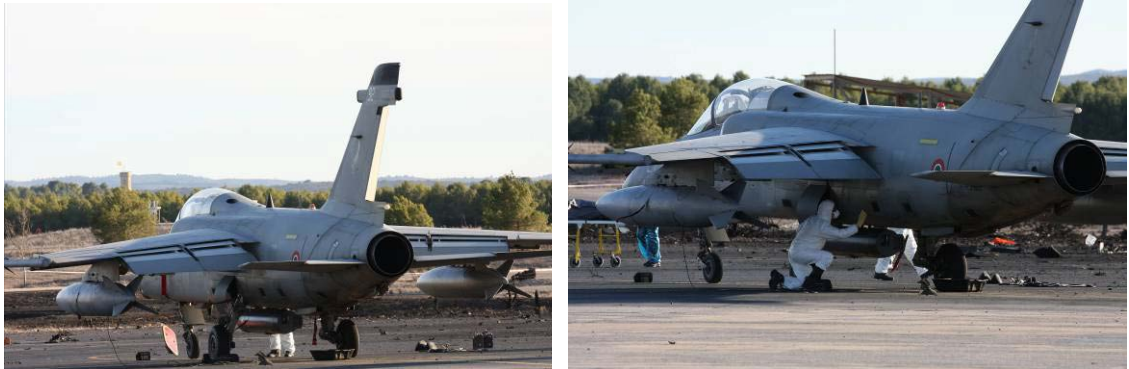
20. AMX S/N 7192

It was located next to AMX S/N 7193 and got slightly damaged.

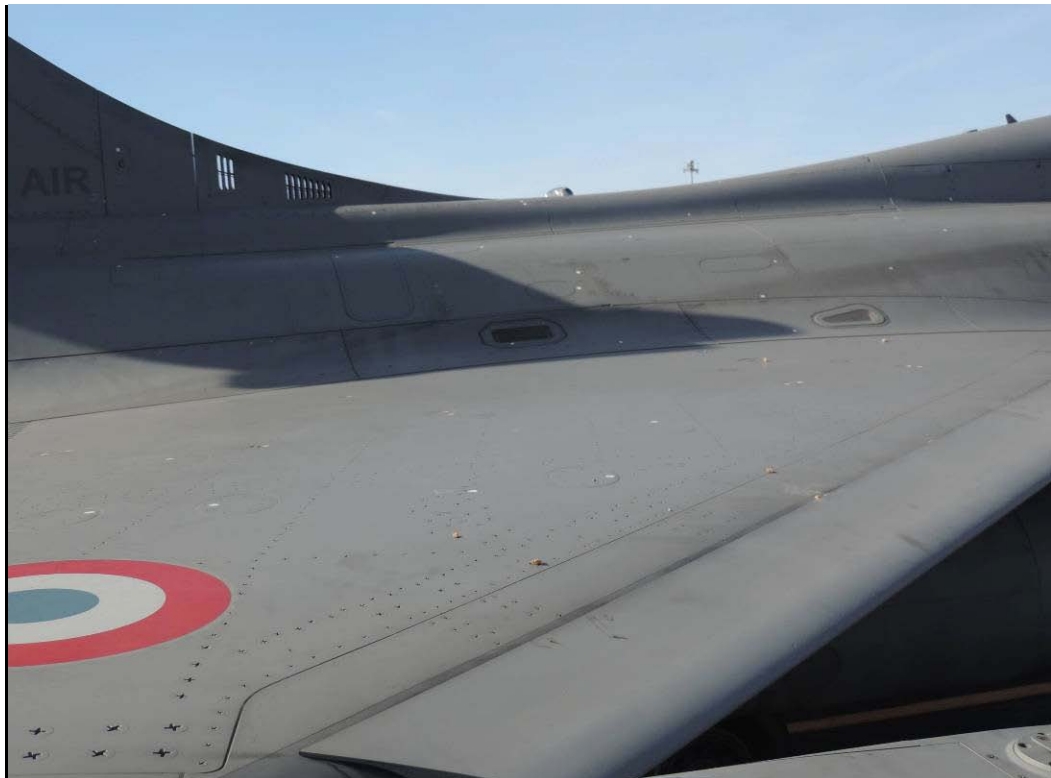
21. Rafale S/N B335

Rafale S/N B335 was parked next to Mirage 2000D S/N 669 and was slightly damaged due to fragmentation after MA's crash.

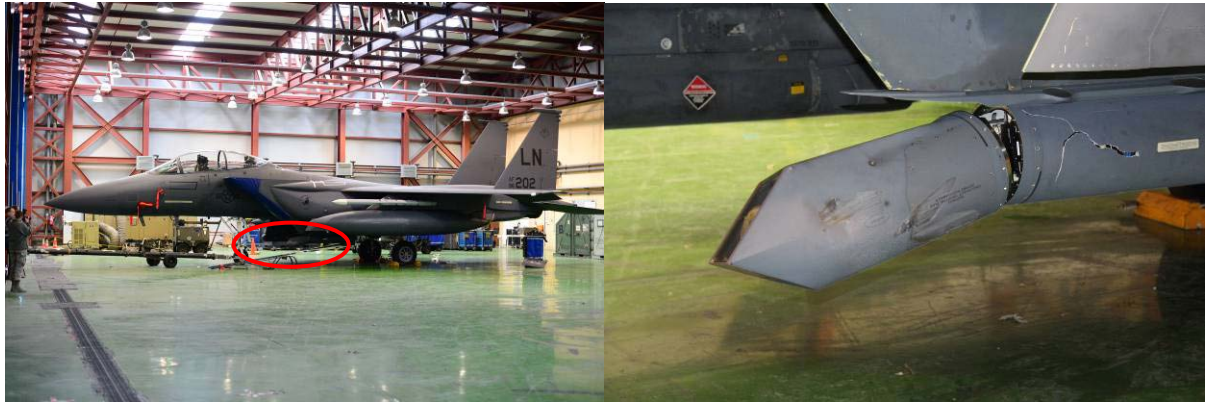
22. F-15 S/N 202

The A/C was located inside TLP Hangar and was slightly damaged.

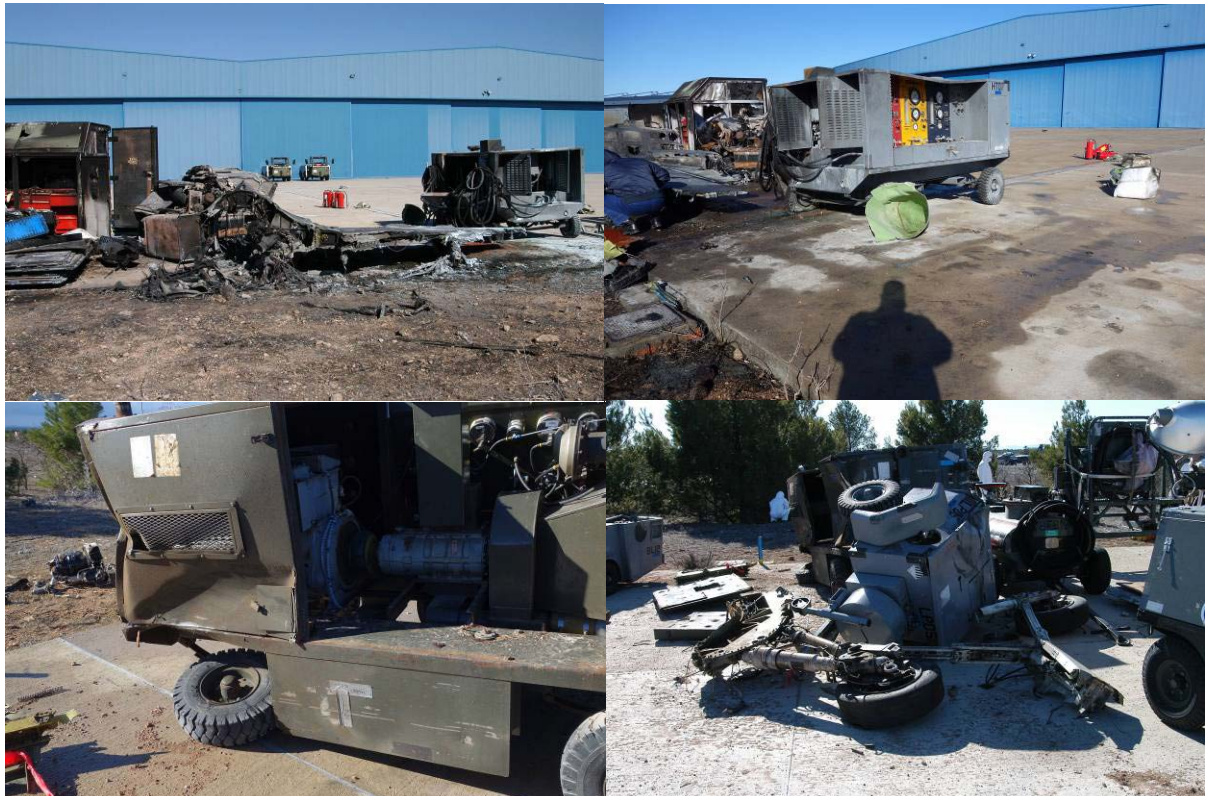
23. Maintenance Ground Equipment

Significant damages were caused to the ground equipment that was located in front of TLP hangar mainly by MLG, RH wing and LH wing of the MA.

Pictures 34: Damages caused by MA's pieces on ground equipment

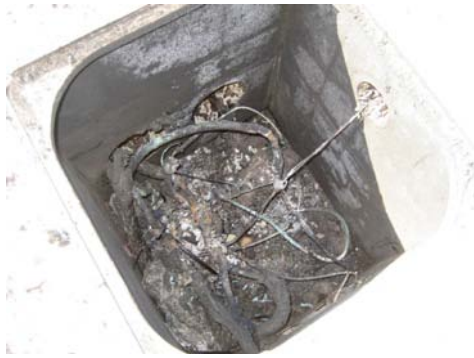
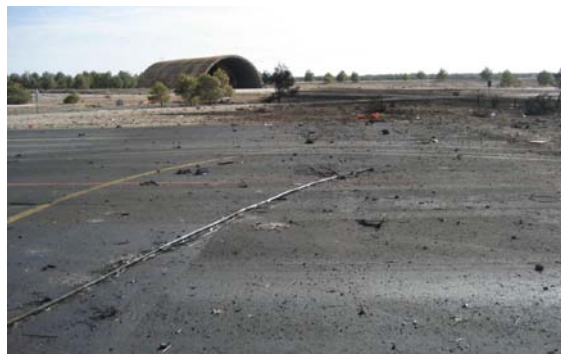
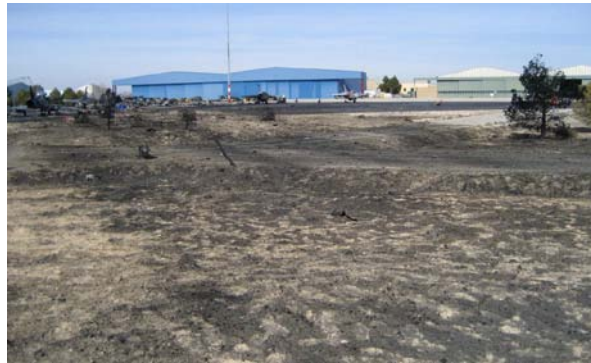
24. Damages to Infrastructure

Significant damages were caused to Albacete and TLP infrastructure in front of TLP hangar, E2 apron parking area and the nearby land.

Pictures 35: Damages to Albacete AFB and TLP infrastructure
