Bureau enquêtes accidents pour la sécurité de l'aéronautique d'État

Safety Investigation Report

I-2016-15-A

Date of event	24 October 2016
Place	Malta International Airport
Type of aircraft	SA227 AT - MERLIN IV C
Company	CAE Aviation

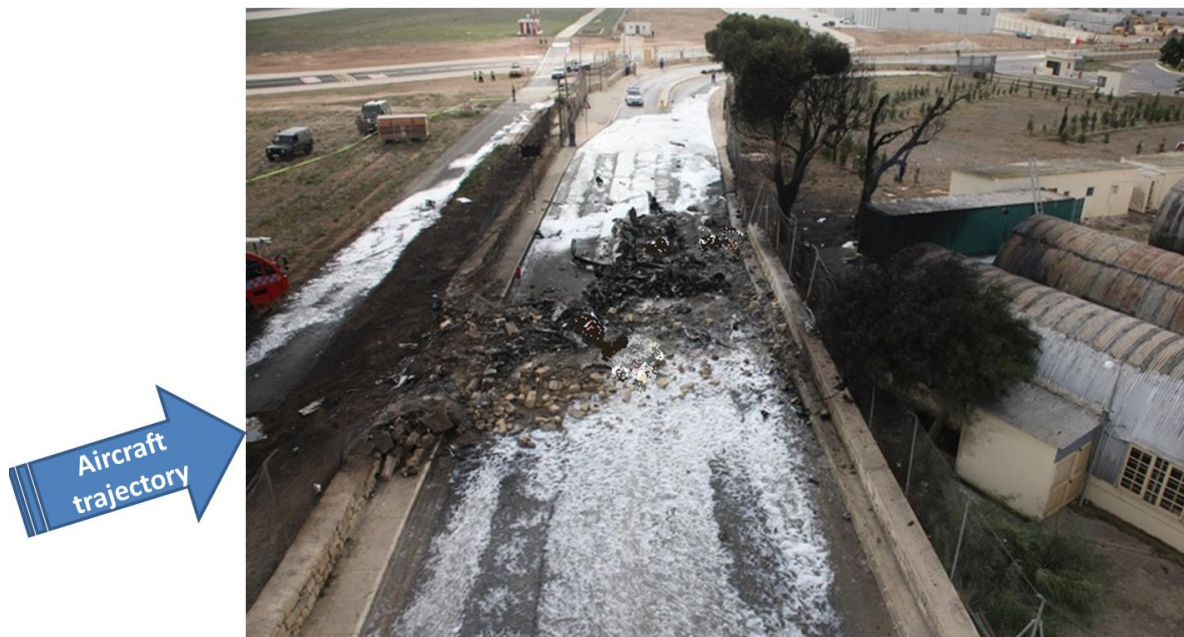
Figure 2: Damage to the perimeter wall, road and surrounding buildings

The impact zone was located at the perimeter wall of the airport. The perimeter wall and the associated fence were destroyed or damaged over a distance of approximately twenty metres. The exterior road and the wall on the other side of the road were damaged over a distance of at least about thirty metres. Three buildings located on the other side of the road were partly damaged or bear traces of the fire that broke out on the ground. Some of the surrounding trees were burned (see Figure 2).

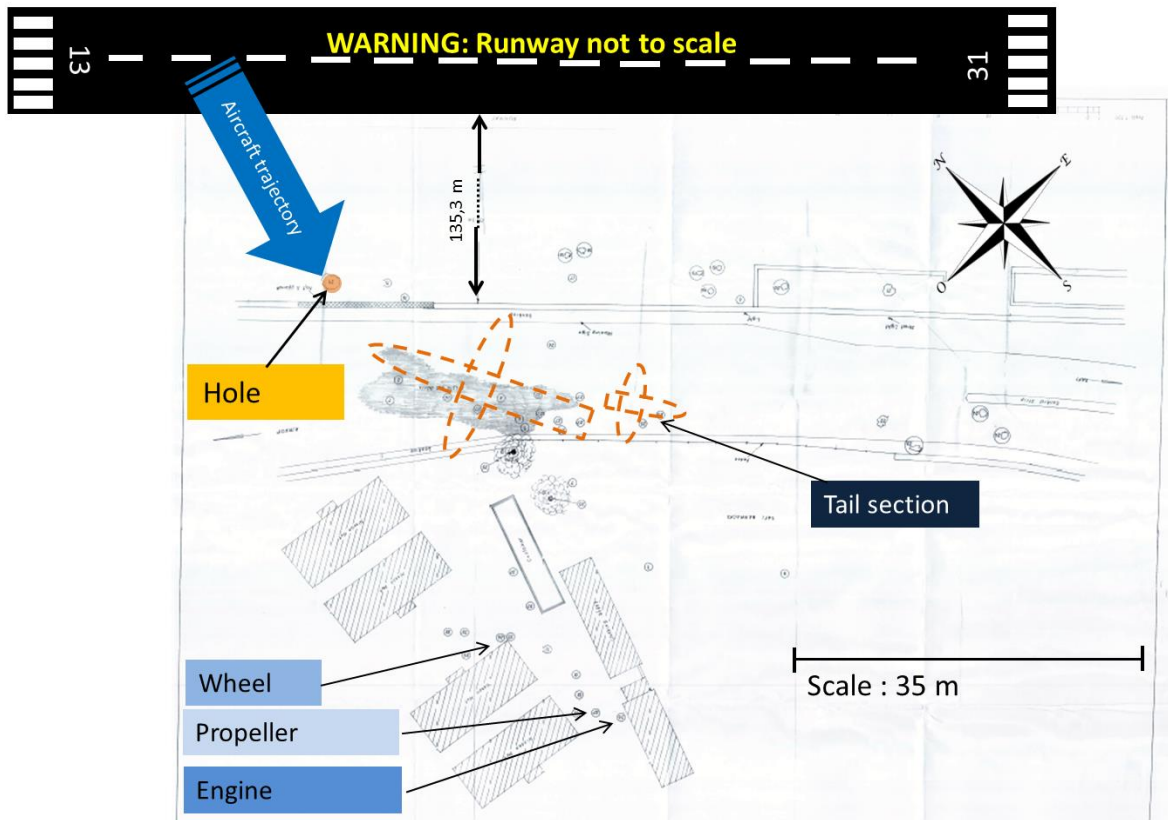
Figure 3: Map of the accident zone

The main part of the wreckage was on the road alongside the airport fence. It was oriented at 350°.

The heaviest components (one of the two engines and one wheel of the main landing gear) were found approximately 30 metres away from the airframe.

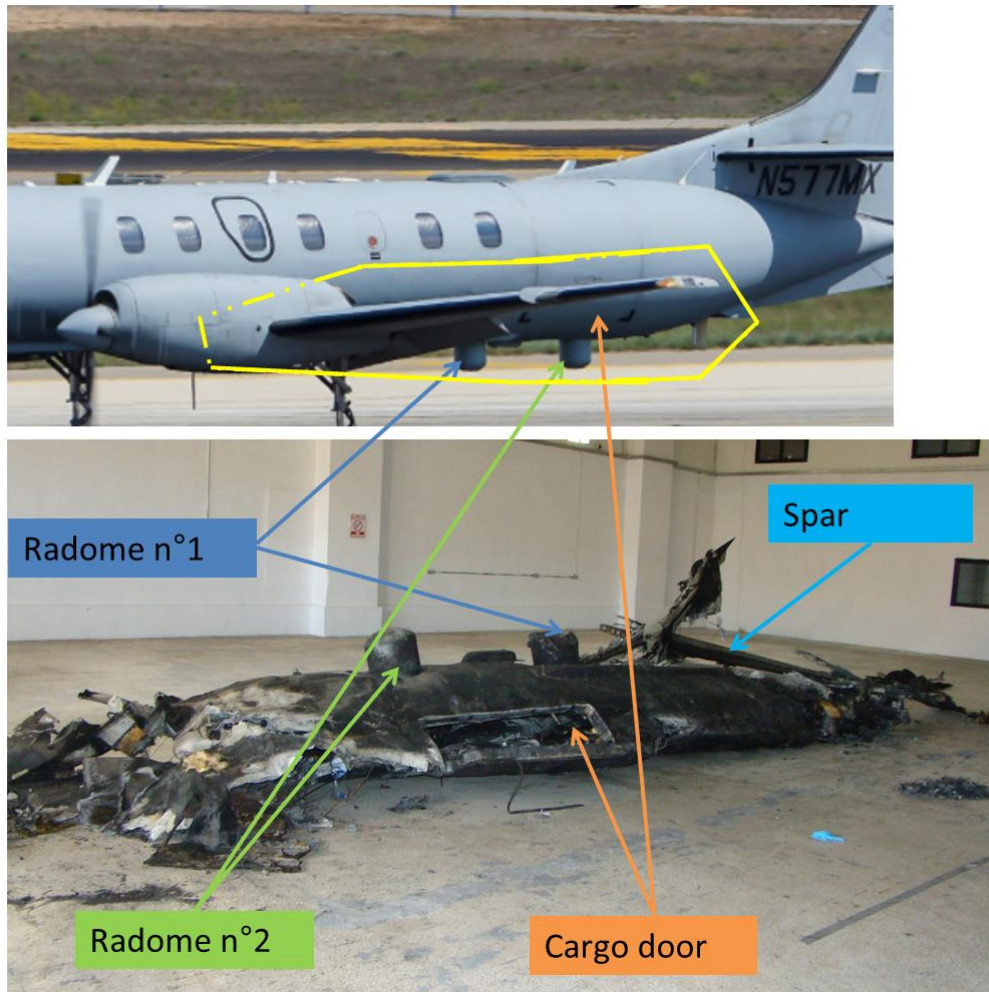
Figure 4: Remaining part of the fuselage

The aircraft was severely damaged by both the impact and the fire on the ground.

Concerning the fuselage, only the lower part behind the wing spar remains in one piece.

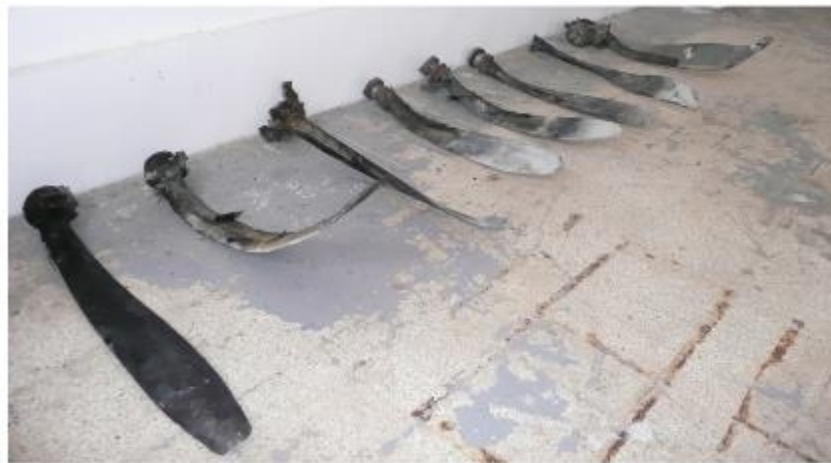
Figure 7: Blades of the 4-blades propellers

The eight blades of the two 4-blade propellers were found separated.

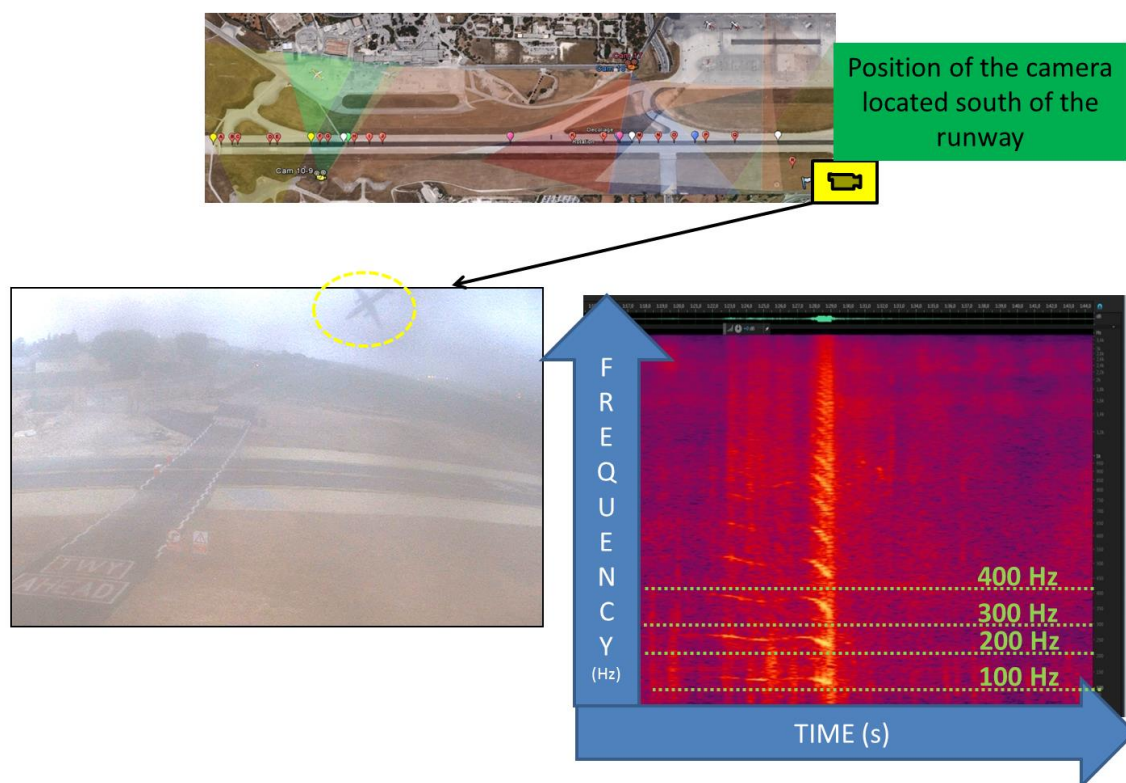
Figure 13: Spectral representation of the sound recorded by a surveillance camera

A spectral representation of the sound recorded by one of the video cameras is reproduced below. On filtering out the Doppler effect¹⁷ caused by the movement of the aircraft, the measurements taken show a frequency of between 101 and 109 Hz for the main line.

A four-blade propeller rotating at 1591 revolutions per minute normally generates a sound spectrum with a main frequency line of approximately 106 Hz and harmonics that are multiples of this frequency.

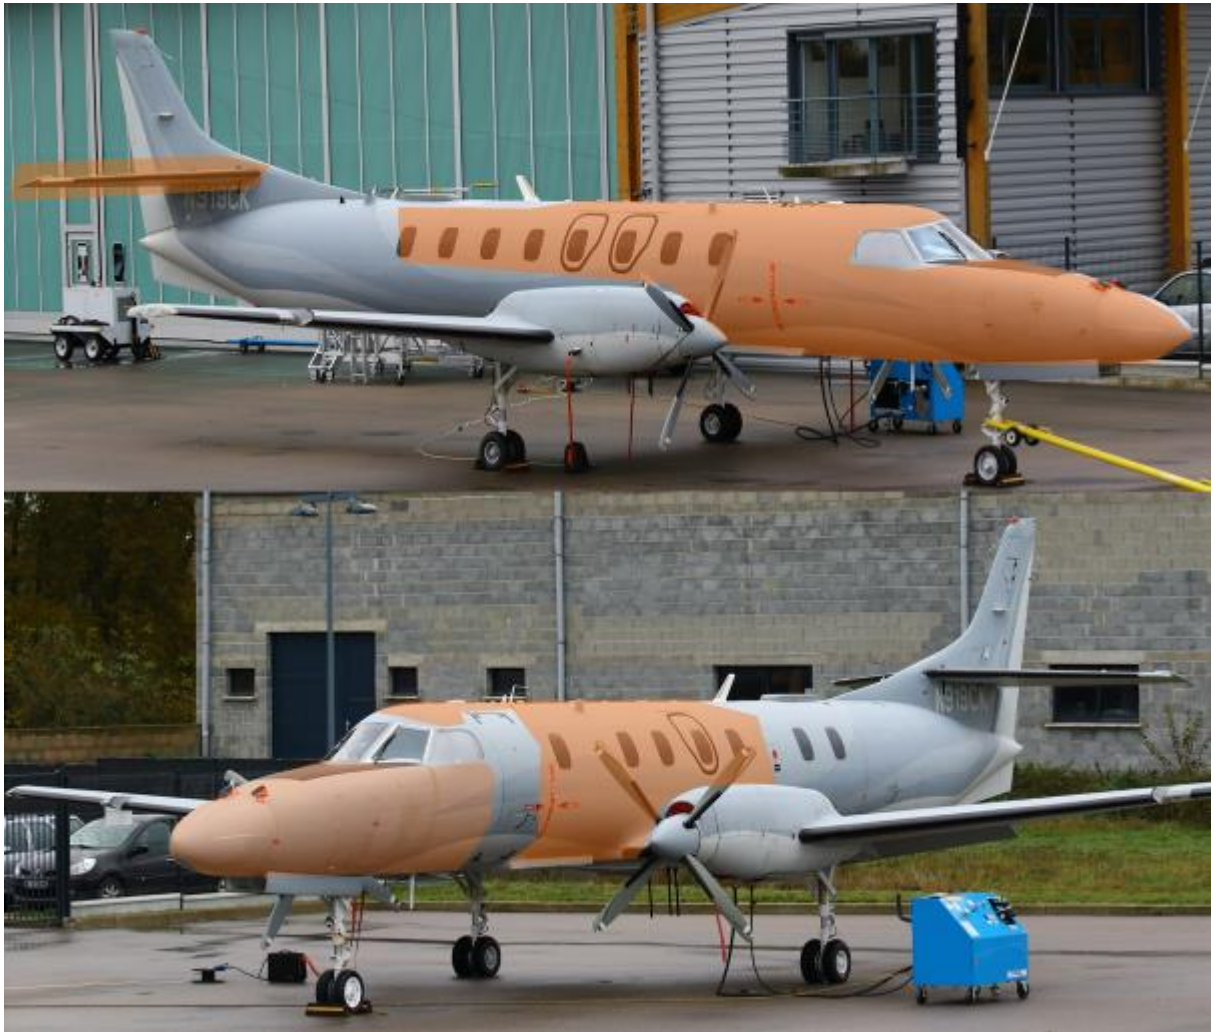
Figure 19: Illustration on the sistership of the missing parts or surfaces of the fuselage (marked in orange)

In the case of the fuselage, the parts or surfaces completely or partially missing are identified in orange in Figure 19.

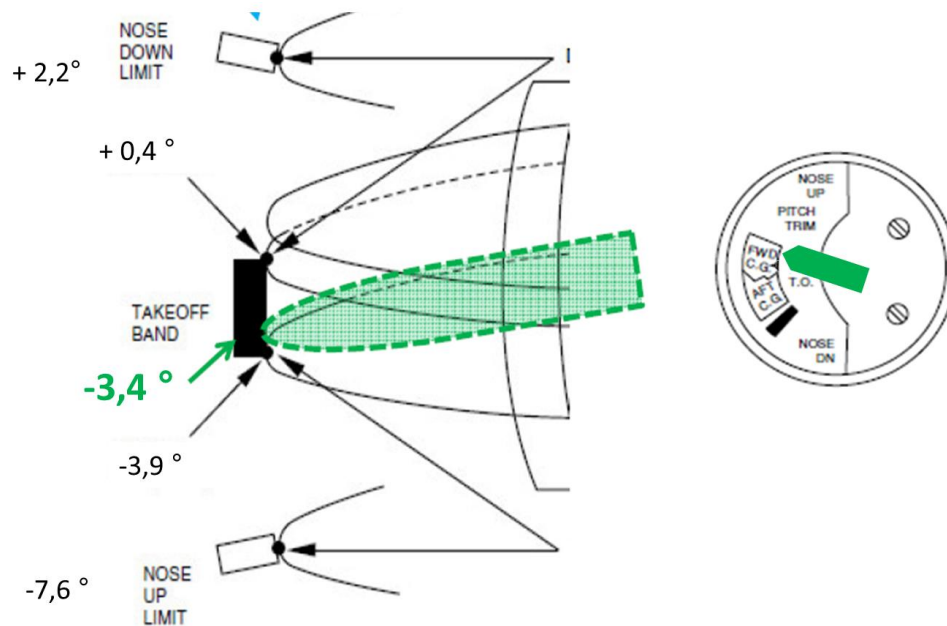
Figure 21: Illustration of the trimmable horizontal stabilizer and its assumed representation on the indicator in the cockpit

- SAS: only the cable drum of the servo control was found. The damage incurred prevented any determination of its condition before impact;
- trim adjustment position: the position of the trimmable horizontal stabilizer was defined on the basis of the trim actuator and corresponded to -3.4° . Given the balance of the aircraft in the middle of the authorized range for the aircraft, this setting induces a "nose up" tendency at low speed (see Figure 21). The variation in attitude observed during a takeoff under the same conditions but without adjusting the elevator after rotation was approximately 10° pitch angle in 3 seconds. This attitude variation is easily controlled by operating the nose-down control.

With the exception of the flaps that were more extended than recommended and the elevator trim setting, which induced a “nose up” tendency insufficient to explain the sharp nose-up observed during the accident, the configuration of the aircraft is as expected during the takeoff phase.
