Appendix B

CRASH SITE AND DAMAGES

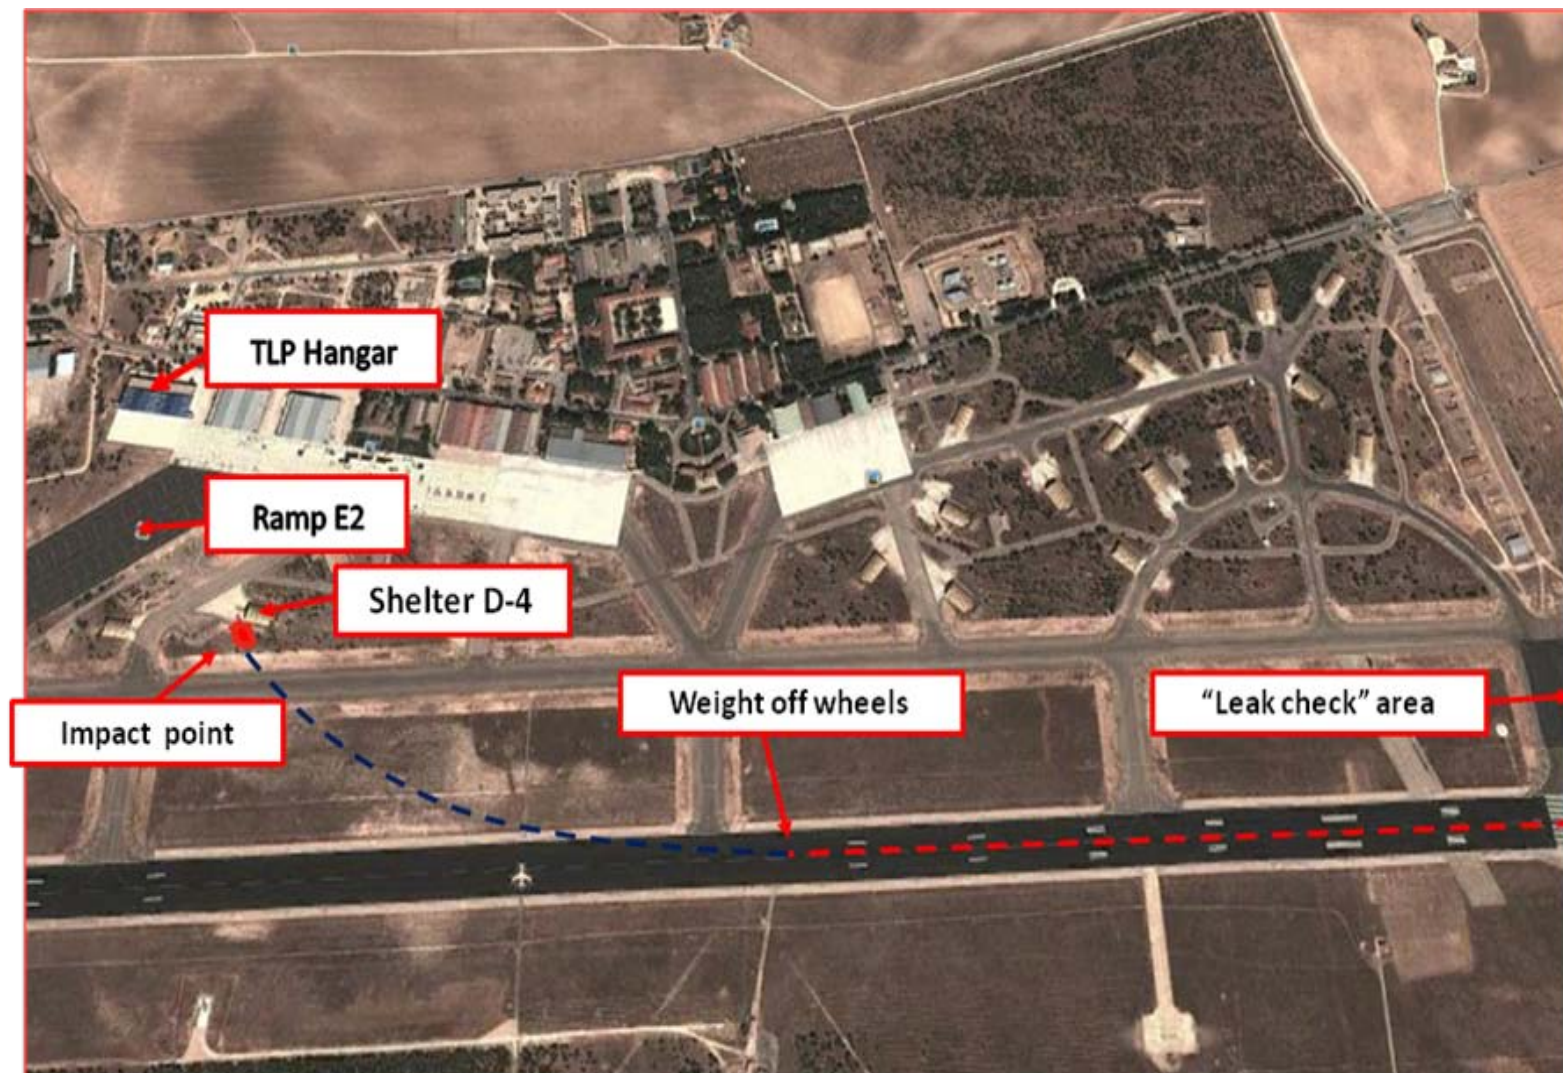
Picture B-1.: View of the Albacete AFB with the main runway, facilities and the MA trajectory (approximate). With red line is the MA trajectory before it becomes airborne and with blue afterwards

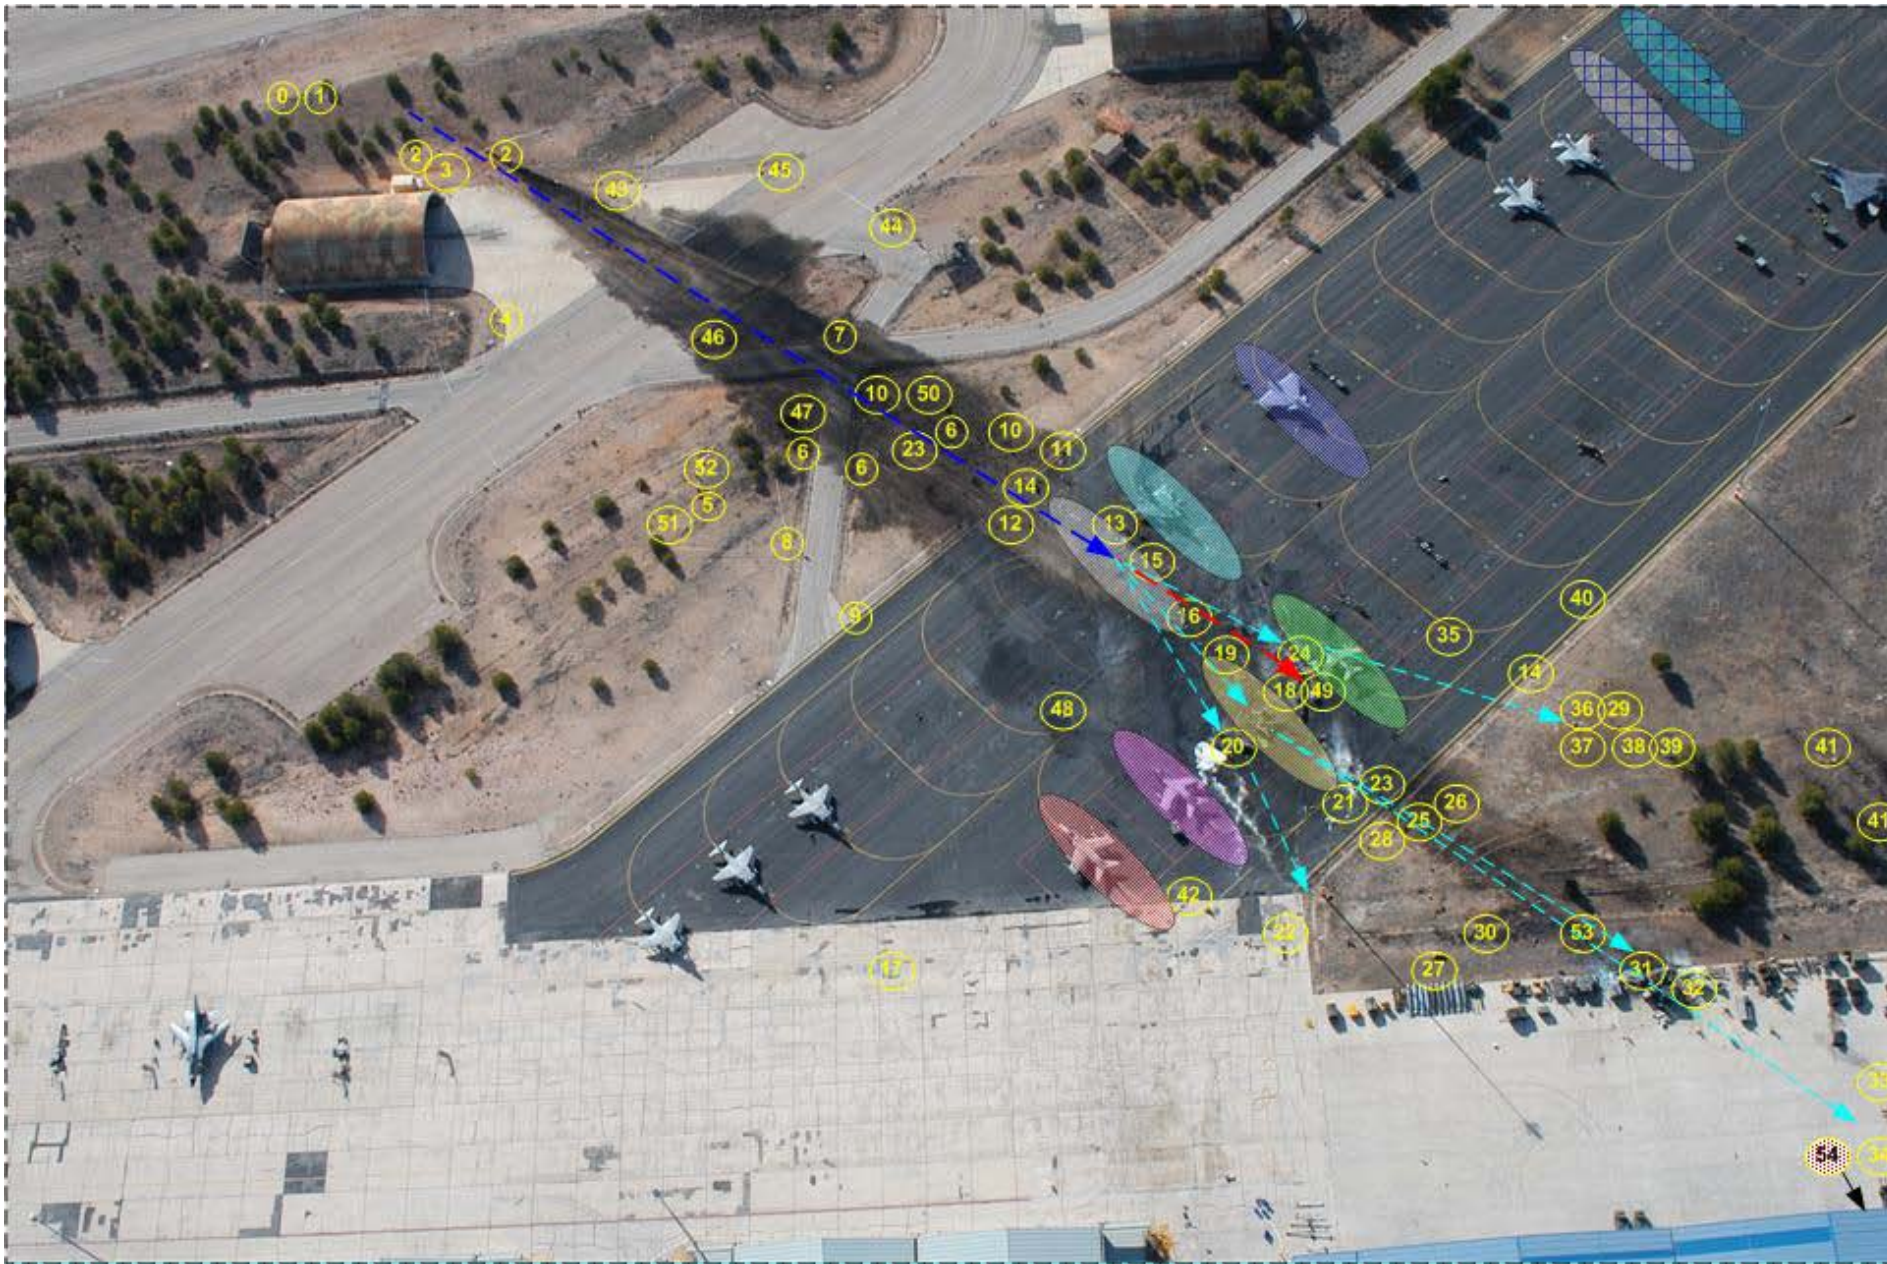
Picture B-2: Aerial view of the wreckage area (for Index please look at the next pages)

- 0: Impact point of MA
- 1: Canopy
- 2: RH leading edge flap rotary actuators (LEFRA) & part of RH LEF
- 3: Recovery parachute (AFT)
- 4: Pitot tube
- 5: FWD Pilot

- 6: Side stick controllers (AFT and FWD)
- 7: RH wing weapon pylon
- 8: Fan Turbine Inlet Temperature (FTIT) indicator
- 9: Taxing light
- 10: Rudder pedals

- 11: RH wing tank
- 12: Data Transfer Cartridge (DTC)
- 13: ACMI pod
- 14: Rudder
- 15: Radome
- 16: LAU-129 (Station 9)
- 17: Part of RH stabilizer and upper surface

- 18: Arresting hook
- 19: Vertical stabilizer
- 20: Engine
- 21: Crash survival memory unit (CSMU)
- 22: Accessory drive gearbox
- 23: Throttle quadrant
- 24: LH horizontal stabilizer

- 25: RH MLG door
- 26: LH LEFRA
- 27: LH speed brake
- 28: LAU-129 & AIM-9 (ST.1)
- 29: AIM-9 guidance section
- 30: M61A1 gun
- 31: LH wing
- 32: Main landing gear (MLG)

- 33: RH wing
- 34: Centerline (C/L) tank
- 35: RH circuit breaker
- 36: RH flaperon
- 37: Electrical power receptacle
- 38: RH stabilizer
- 39: Aircraft Launcher Interface Computer (ALIC)

- 40: Nose landing gear (NLG)
- 41: AGM-88 (HARM)
- 42: AFT frame with MFD panels
- 43: AFT Pilot
- 44: AFT ejection seat parts
- 45: RH asymmetry brake assy

- 46: Mount of RH LEF with LEFRA
- 47: Trim panel
- 48: RH angle gearbox
- 49: Jet fuel starter (JFS) accumulator
- 50: ACMI memory card
