Bureau enquêtes accidents pour la sécurité de l'aéronautique d'État

Safety Investigation Report

I-2016-15-A

Date of event	24 October 2016
Place	Malta International Airport
Type of aircraft	SA227 AT - MERLIN IV C
Company	CAE Aviation

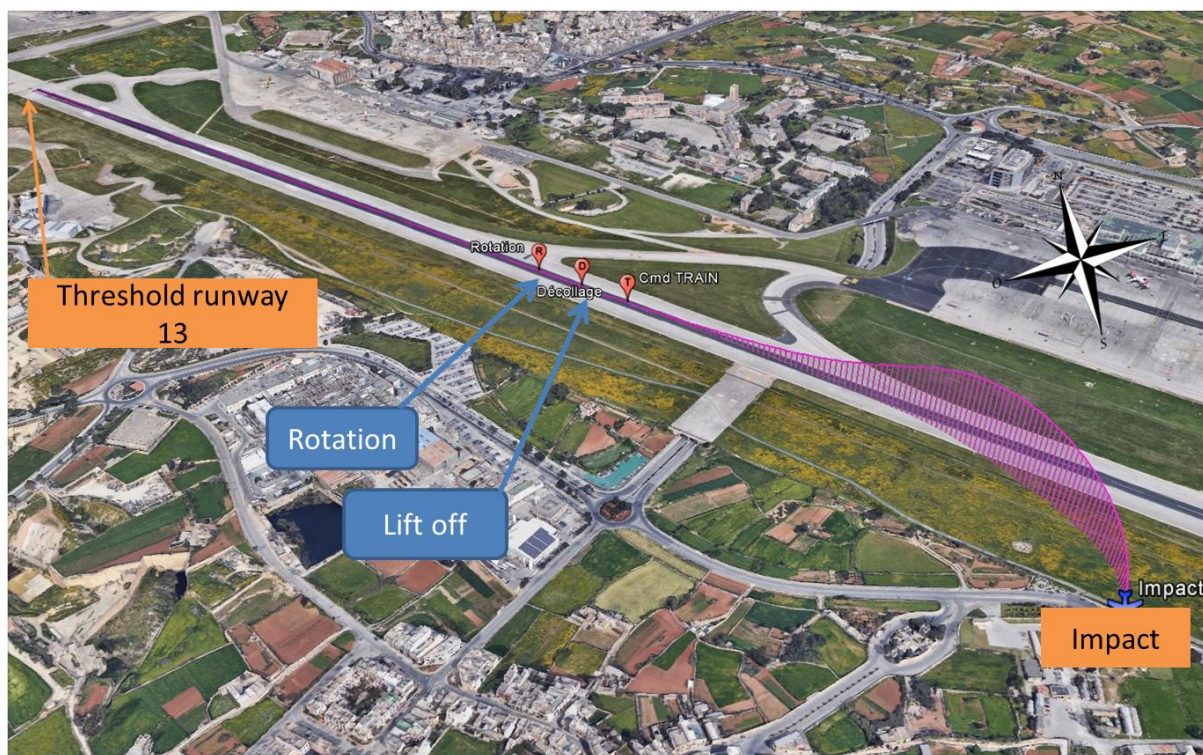
Figure 1: Reconstitution of the aircraft's trajectory

The plane was observed in a three-quarters inverted position at the apogee of its trajectory.

A reconstitution of the flight path is presented in Figure 1.

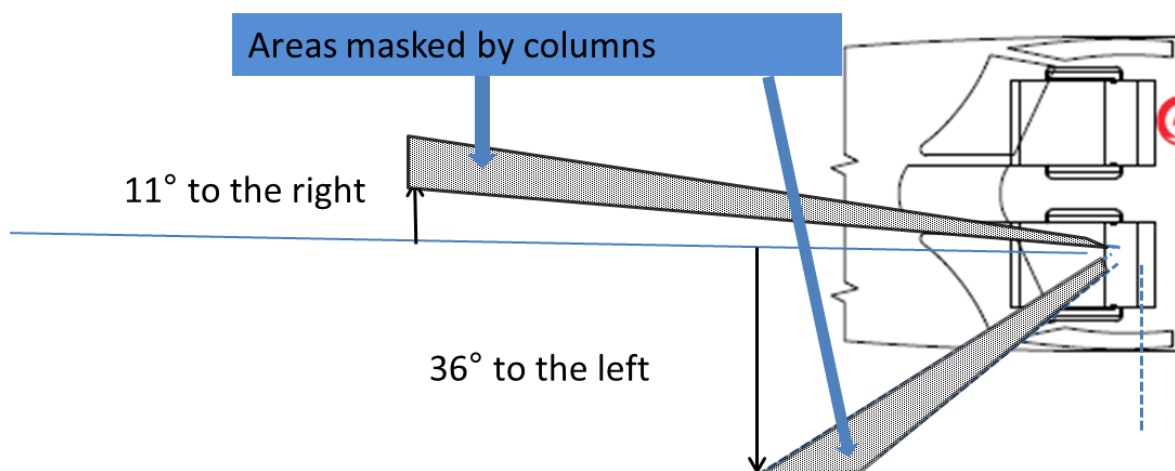
Figure 15: Field of vision of the pilot in the horizontal plane

The zones masked by the uprights do not impede to piloting the aircraft or to detecting obstacles on the takeoff trajectory.

The characteristics of the cockpit do not cause any visual obstruction for normal takeoff.

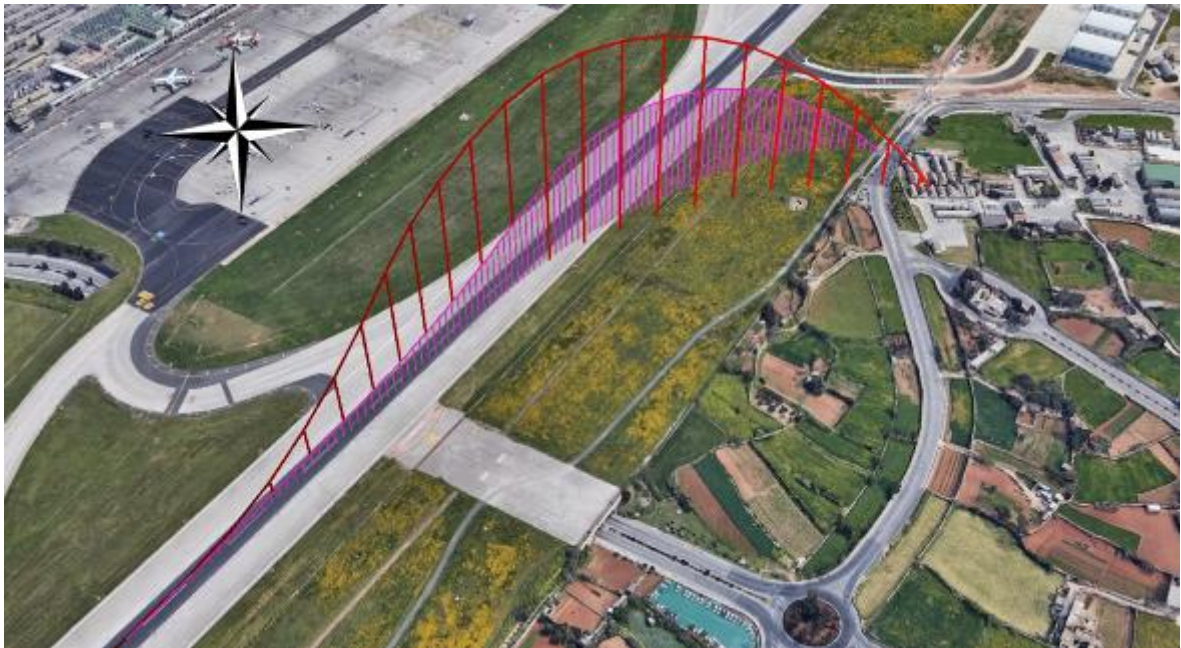
Figure 16: Comparison of the flight path of the PC7 (red) with that of the accident (magenta)

The condition that yielded the most faithful approximation of the flight path of the accident consists in maintaining and fixing the same stick position on the pitch axis (rear sector or nose-up sector), yielding a pitch attitude variation of 30° in 3 seconds at the beginning of the flight path. Despite different aerodynamics on the PC7, the characteristic points of the flight path were situated at essentially the same times. On repositioning the displacements of the PC7 with this condition in the environment of the accident, the comparative result is presented below:

Analysis of the flight path of the SA227 AT shows that it recovered the effectiveness of the controls after reaching the three-quarter turned position, as revealed by an inversion of the rate of roll. The descent path reveals that the nose-up elevator control was maintained in the same position.

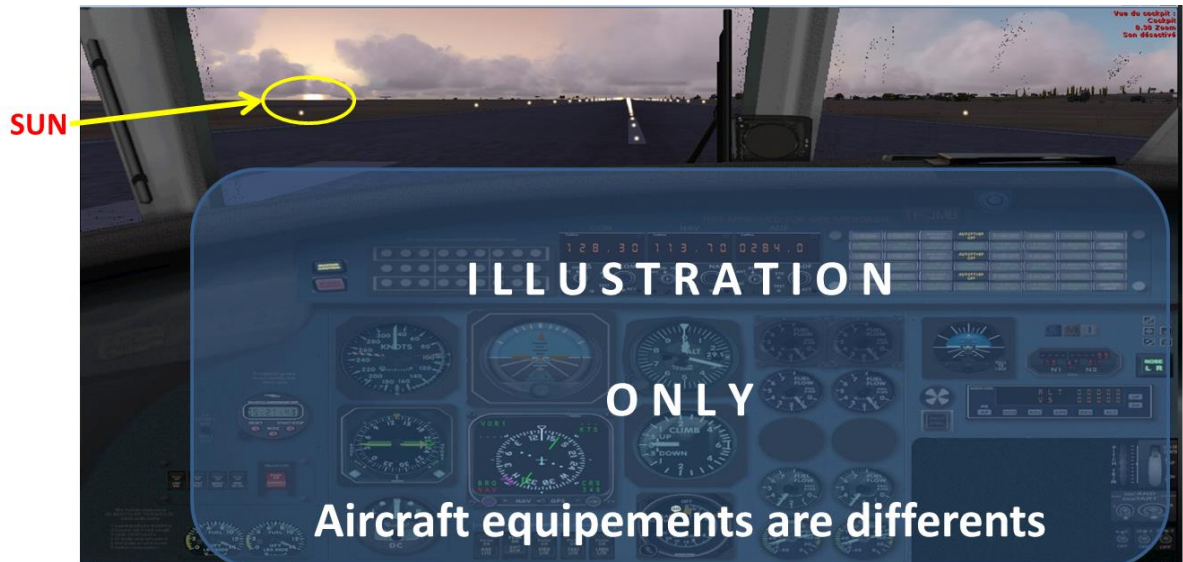
Figure 22: Position of the sun before rotation (on left seat)

The takeoff took place at dawn. Sunrise on the day of the accident was effective at 07:17. The azimuth at sunrise is 104 degrees. The position of the sun in the cockpit before rotation is represented in Figure 22. The representation of the meteorological conditions has been enhanced to show the sun.

The hypothesis that the position of the sun hampered the pilot is rejected.

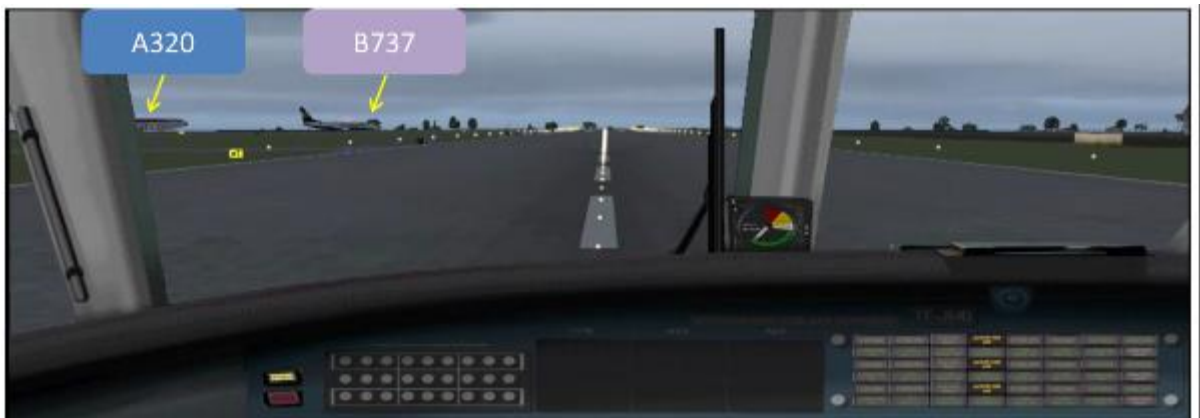
Figure 23: Relative position of the aircrafts at the moment of rotation

A reconstruction of the view from the cockpit of the accident aircraft before rotation (based on the video recordings in the case of the A320 and the flight recorder of the B737) enables the distance between the aircraft to be measured (see figure 23).

Also, the SANDEL Avionics control unit (see Annex 3) recorded the transmission of at least one traffic information message during the takeoff phase. The proximity of these aircraft could have triggered a visual and aural warning message generated by the TCAS of the aircraft involved in the accident.

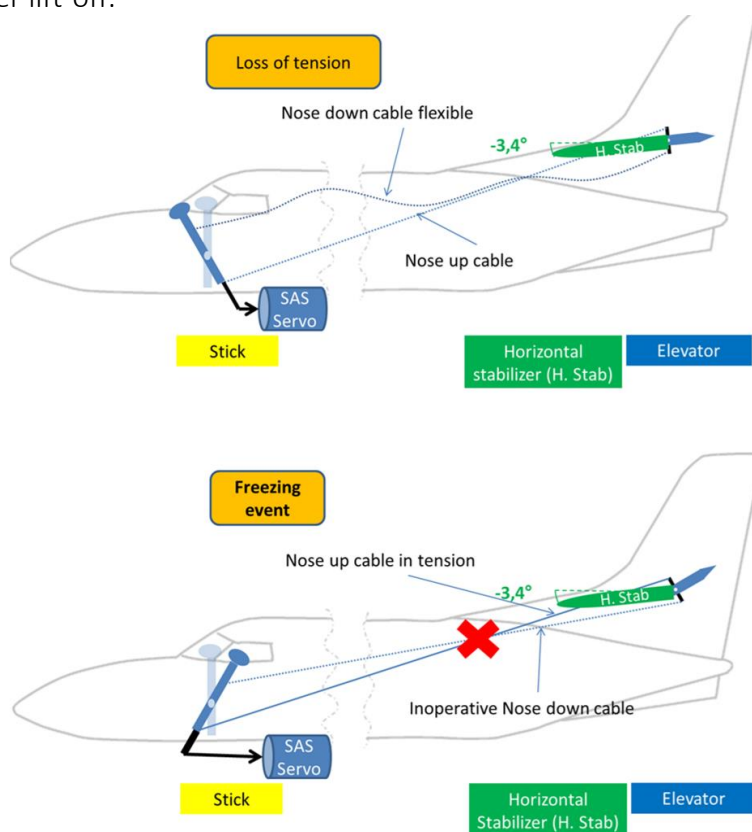
Figure 28: Diagram illustrating the two investigated fault scenarios

In this situation, one solution for recovering control of the aircraft would be to act rapidly on the elevator trim to set the horizontal stabilizer into the “nose down” sector. According to the data in the maintenance manual, the shortest time necessary to attain this trim range is approximately 8 seconds from position -3.4° .

However, control of the aircraft cannot be recovered once it has stalled, which means less than 4 seconds after lift-off.

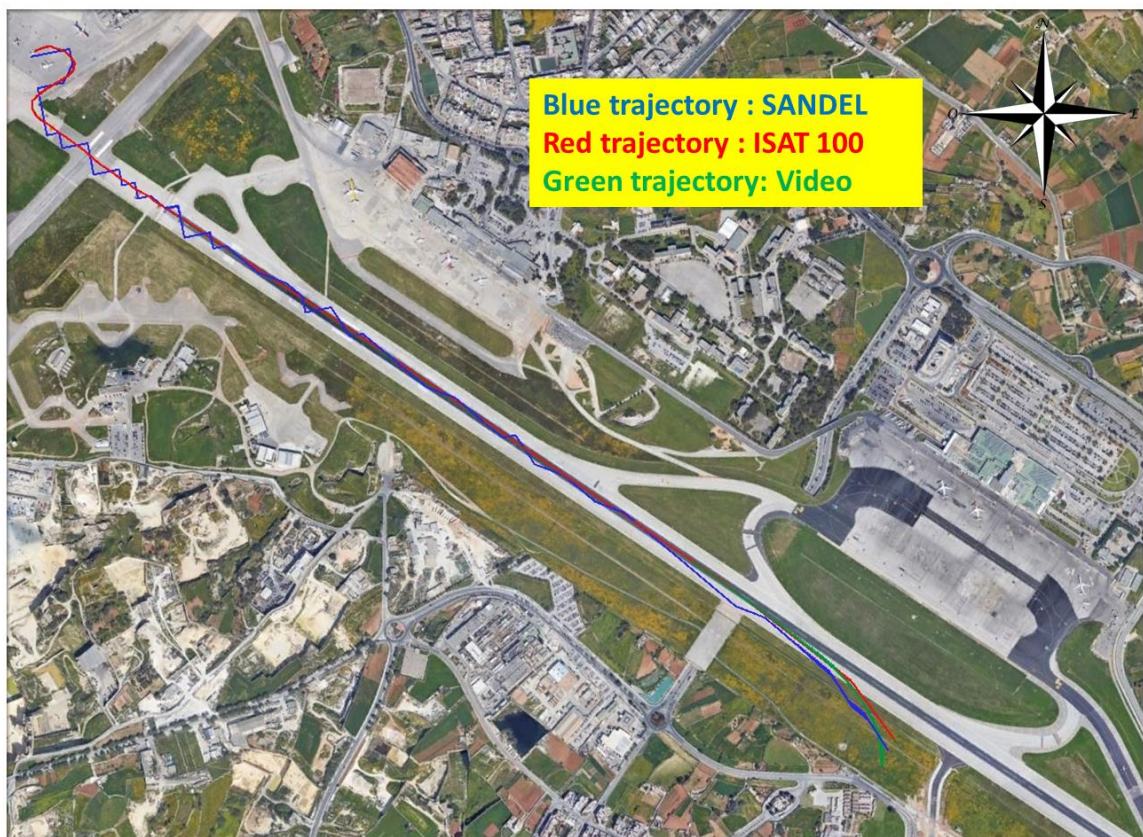
Figure 30: Compared flight paths of the aircraft after reconstitution (seen from above)

The end of recording prevented obtaining information up to the moment of impact.

The flight path obtained from the recordings is shown below, compared to the flight path derived from analyzing the videos from three different angles.

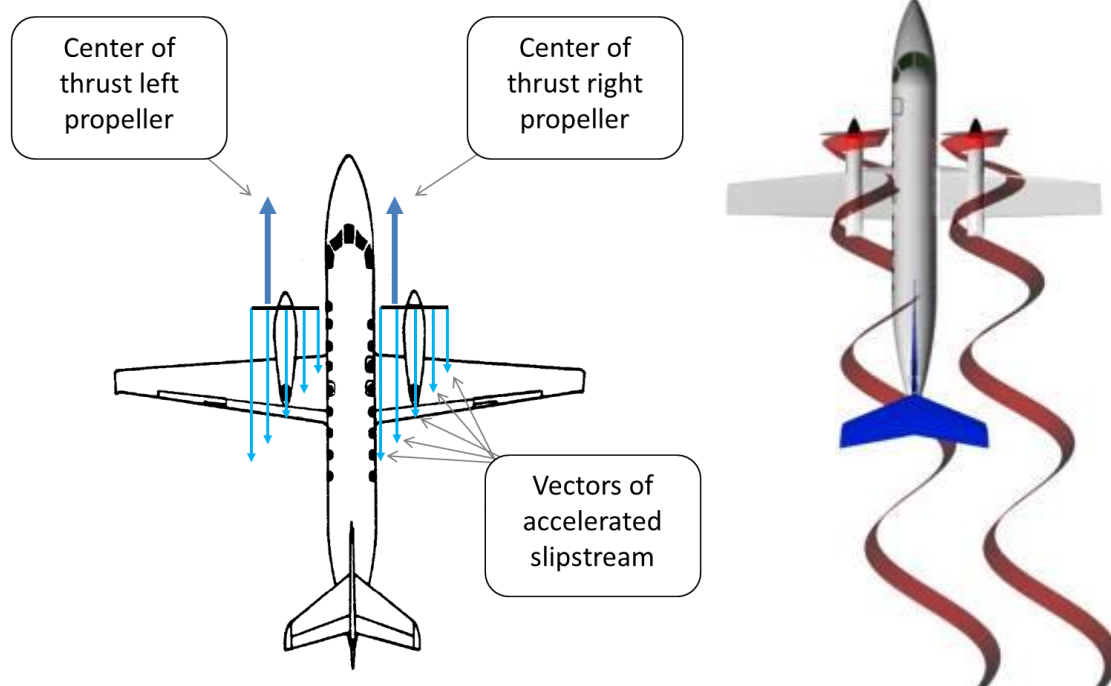
Figure 35: illustrations of the airflows and centers of thrust of the propellers on the SA227 AT

- asymmetrical distribution of lift, which is stronger on the descending blade side, so that the left-hand wing is better supplied than the right;
- local increase in the angle of attack of the right-hand wing, due to the helicoidal slipstream (descending on the left, ascending on the right).

The right-hand wing will therefore tend to stall first, accompanied by a sharp roll to the right.
